## Giornate aicap 2014

Bergamo 22 – 24 Maggio 2014

# Durability of reinforced concrete structures – Problems and Progress

**Bernhard Elsener**

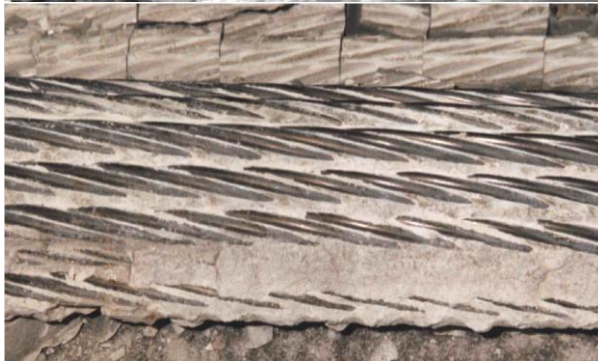
**Passivation:**

In the alkaline pore solution (pH 13) a protective oxide film is formed on the steel surface  
(passive film, similar to CrNi steel in water)

Steel in alkaline environment of concrete is passive

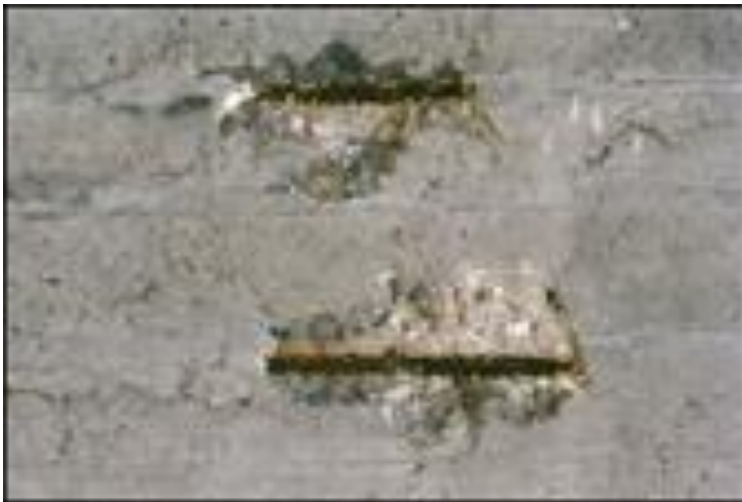
Corrosion due to carbonation

Uniform corrosion with rust formation

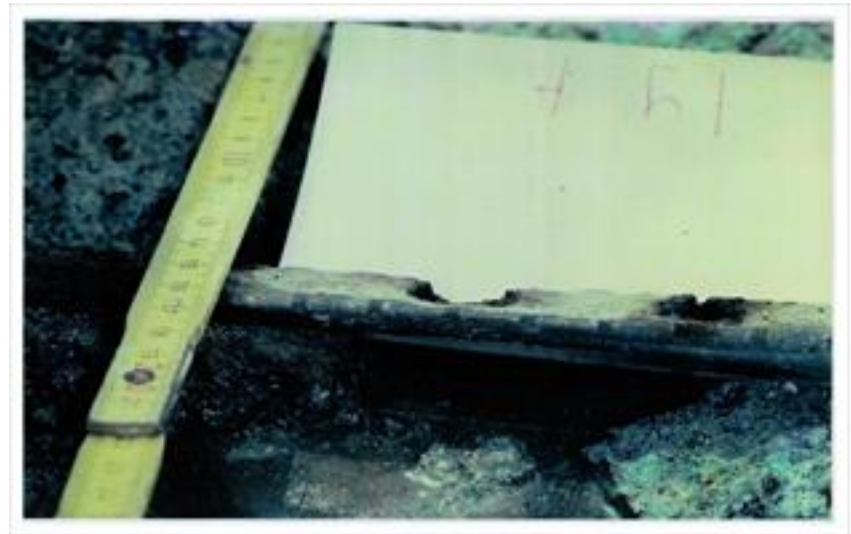
Typical corrosion attack in a bridge deck with high chloride concentration

**Note:** very often the localized attacks appear blank, without rust. Visual inspection might not reveal corrosion damage (cracks, delamination).

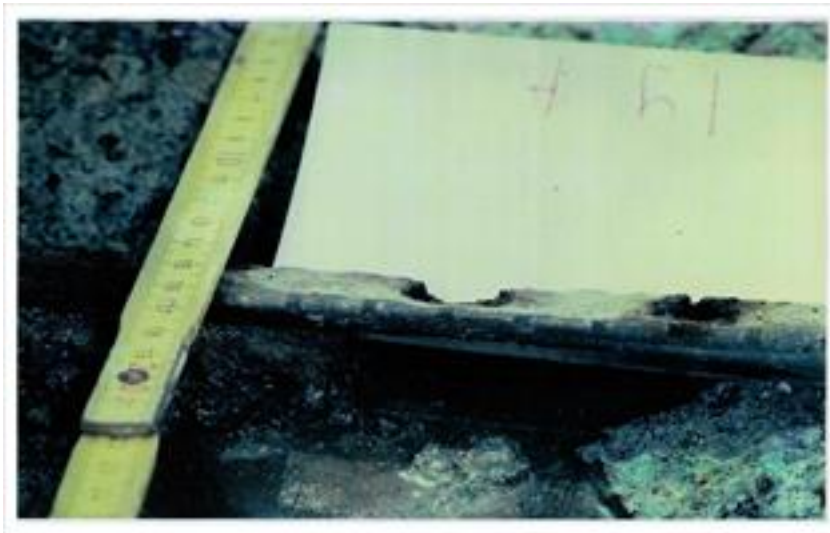
Typical corrosion attack in a bridge deck with high chloride concentration. Loss in cross section, **no rust formation !**

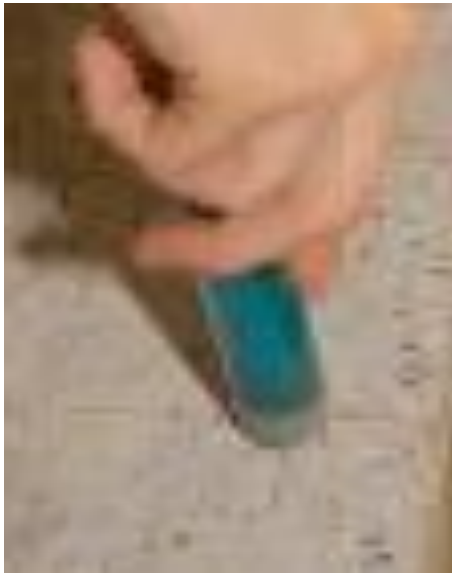
single electrode

This technique is today **state of the art** in condition assessment of reinforced concrete structures (national and international guidelines)....

It can – in principle – be used also for **regular inspection** of RC structures

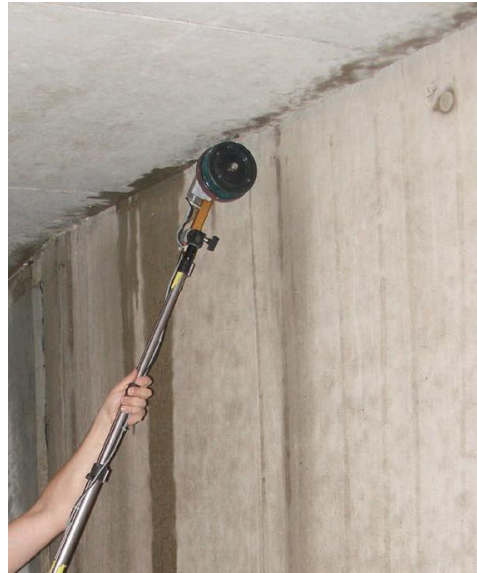
single wheel electrode

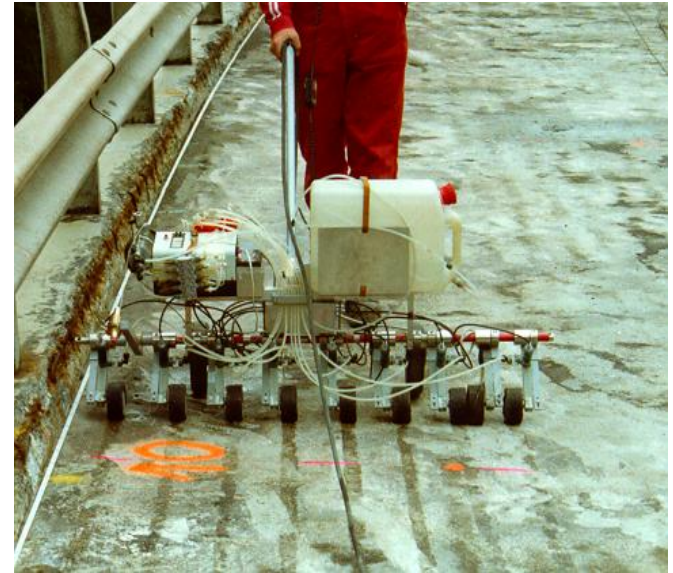
8 wheel electrode

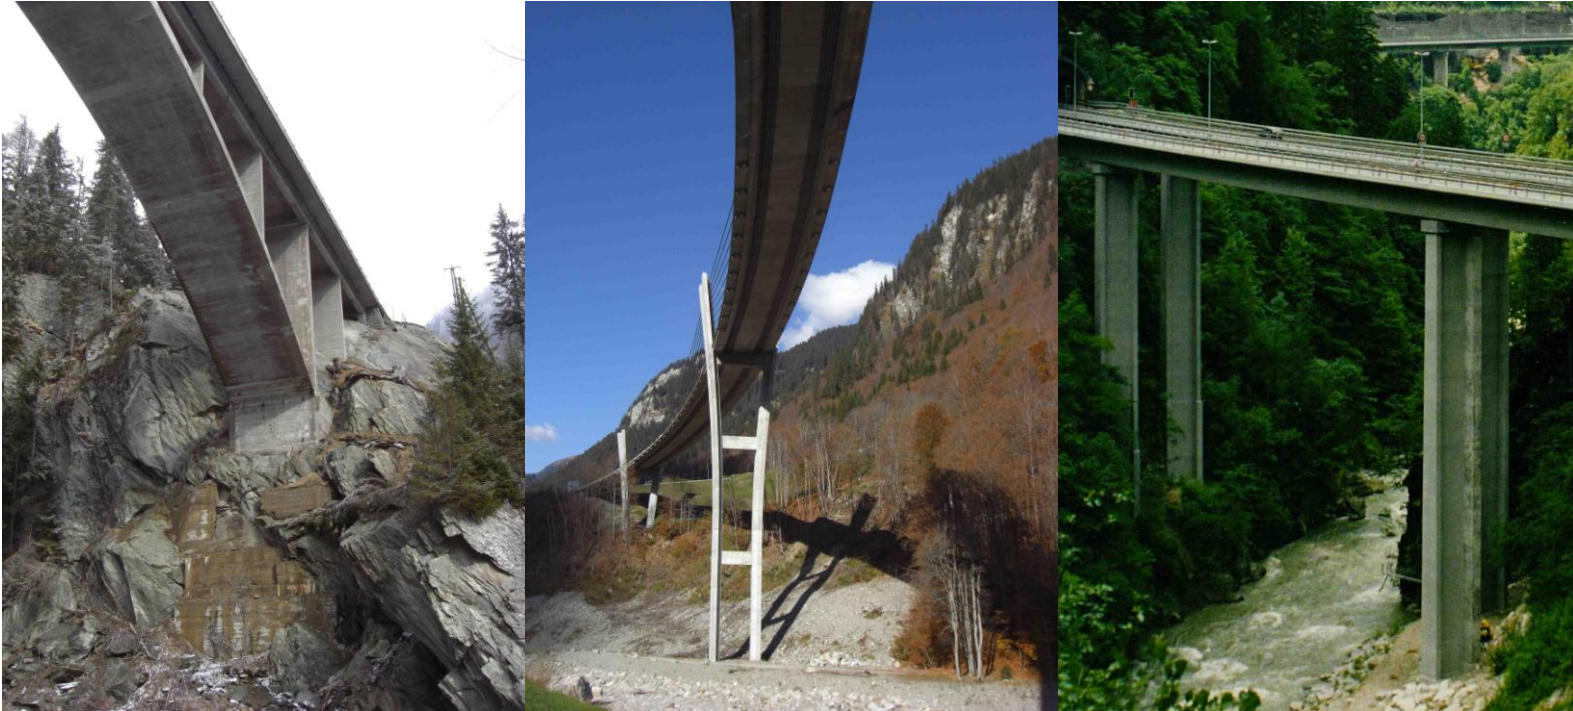
## Difficulty to reach and “touch” the concrete surface.....

With the result that **we still rely on visual inspections only ....**

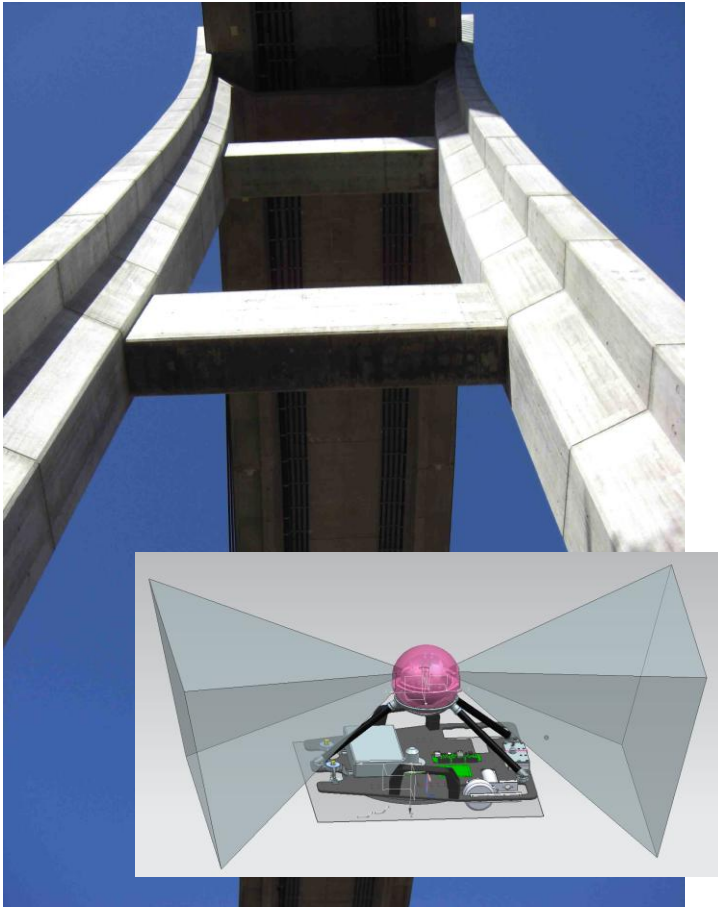
## Climbing corrosion detection robot

- Vortex system
- Half cell potential wheel
- Continuous operation (power supply)
- Can be equipped with more sensors

**Regular inspections will have much higher quality of information.**

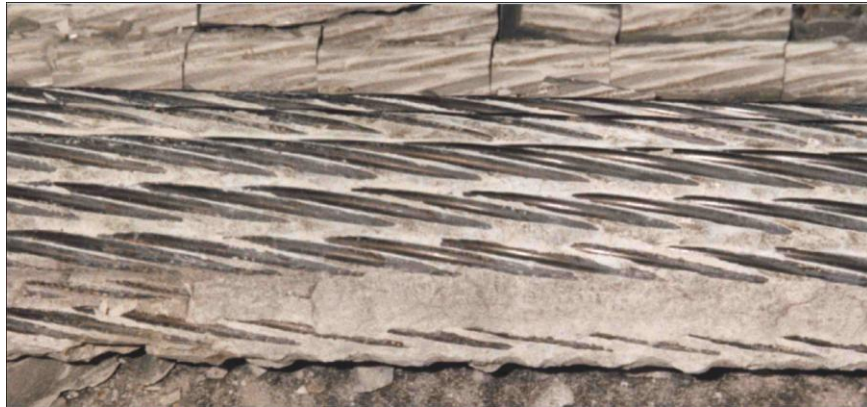
Traditional metallic ducts in more than 90% of all structures successful and durable over whole service life

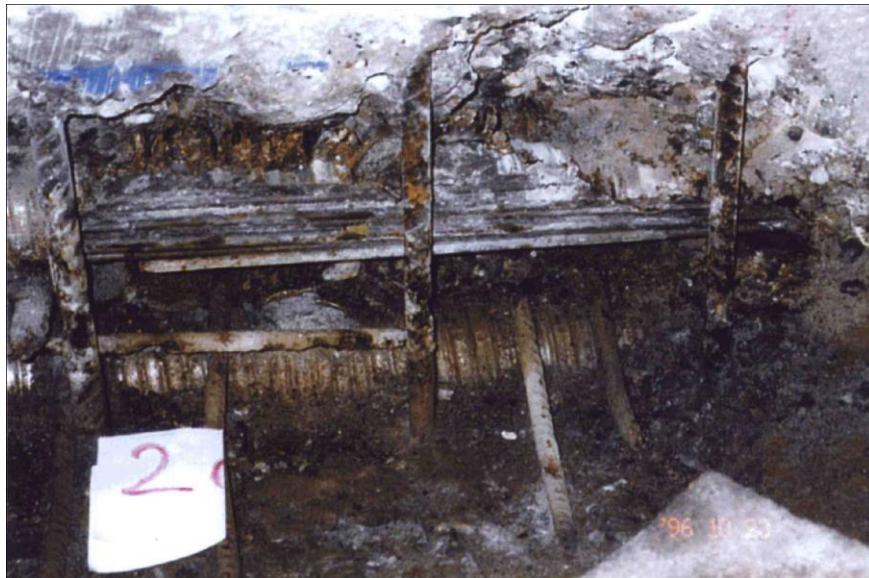
In several cases severe corrosion of the strands in the grouted tendons was detected

- Collapses without warning
- No established NDT technique

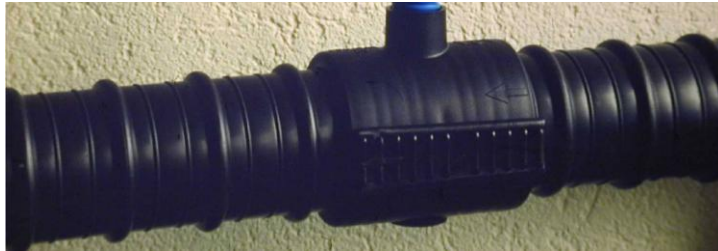
## New approach: Thick wall corrugated polymer ducts

### Thick corrugated plastic ducts

Tight envelope, avoids chloride ingress to the high strength steel

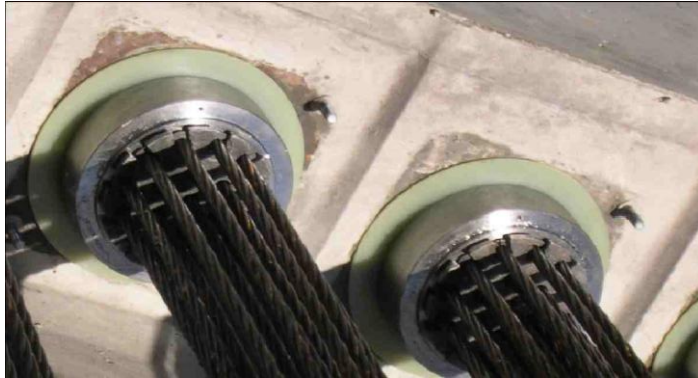
## New approach: electrical isolation of the high-strength steel

### Electrical isolation

Insulating anchor plates, plastic trumpet for anchorages

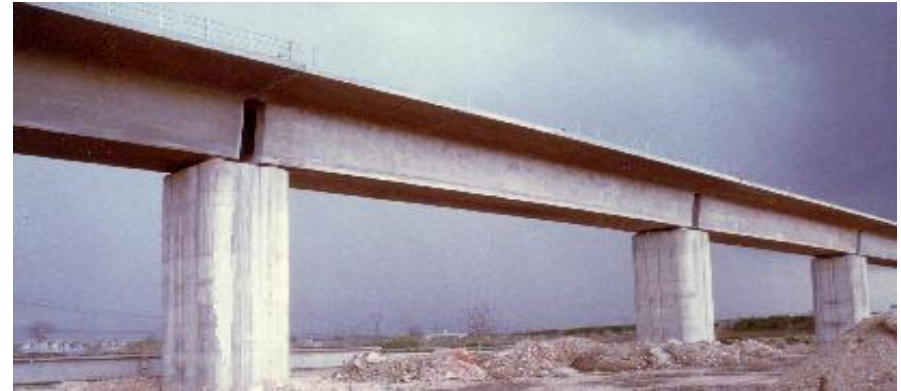
18% of the length are viaducts,  
simply supported P.C. spans

PADULICELLA VIADUCT, ROMA-NAPOLI

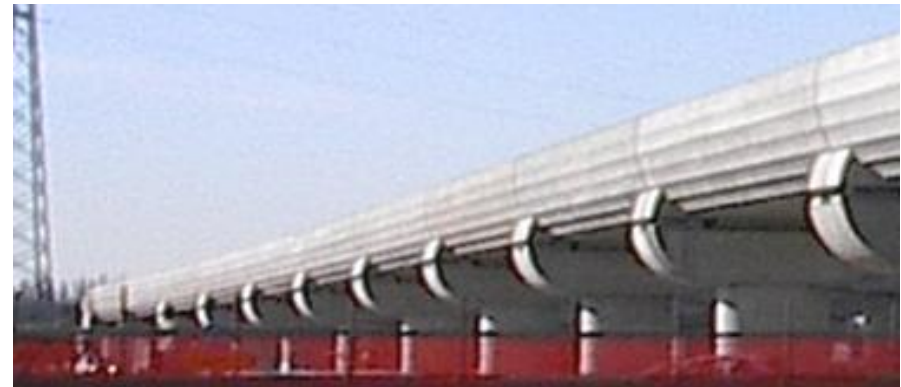
MODENA VIADUCTS, MILANO-BOLOGNA

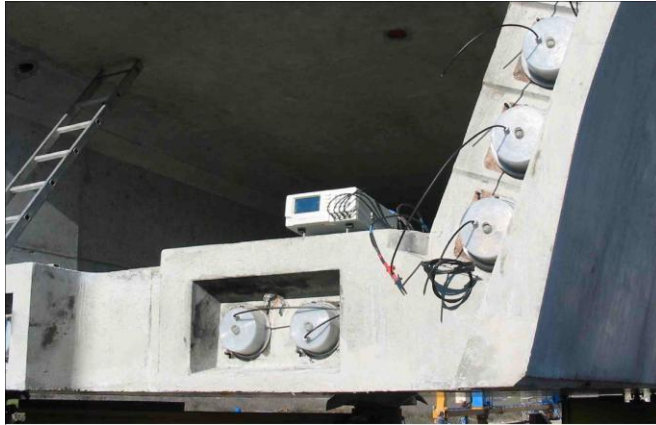
- No sensors needed - the tendon under test is the sensor
- Rapid AC resistance measurements at any time during service life
- **Quality control of execution**

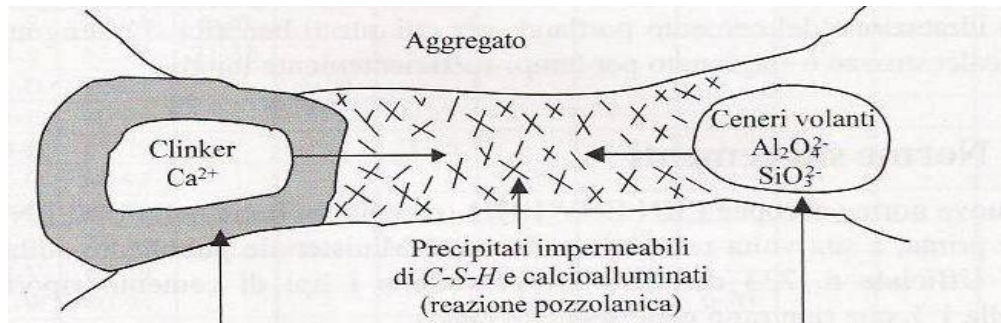
### Pozzolanic reaction

- Pozzolanic reaction (cement paste is formed in the pores)
- Filler effect (limestone)
- Lower hydration heat evolution

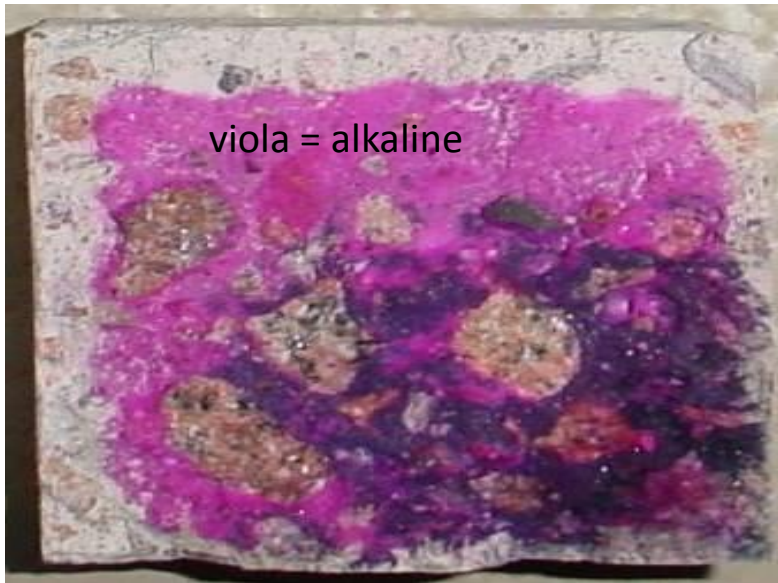
pH value as indicated by phenolphthalein

In carbonated concrete the pH value drops to  $< 10$ : **steel depassivation**

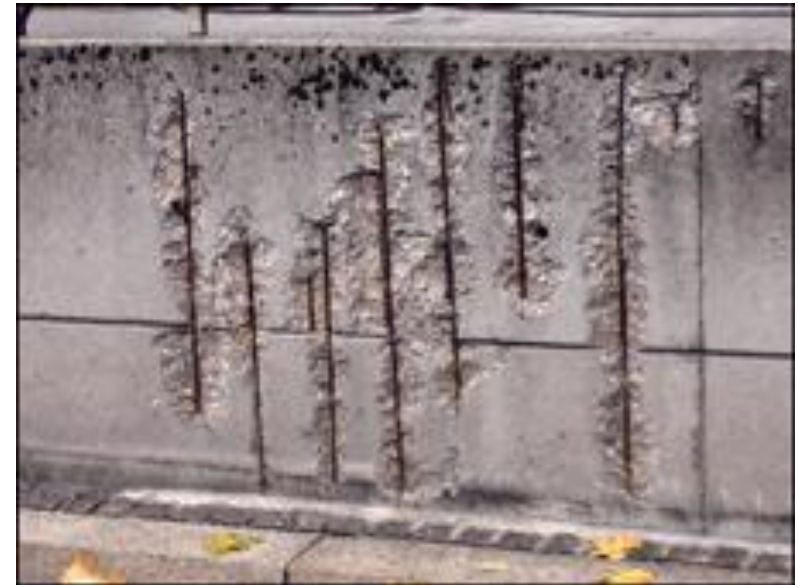
In presence of  $\text{H}_2\text{O}$  and  $\text{O}_2$   
rust products are formed

Iron oxides (rust) are more voluminous than steel: **cracking or spalling**

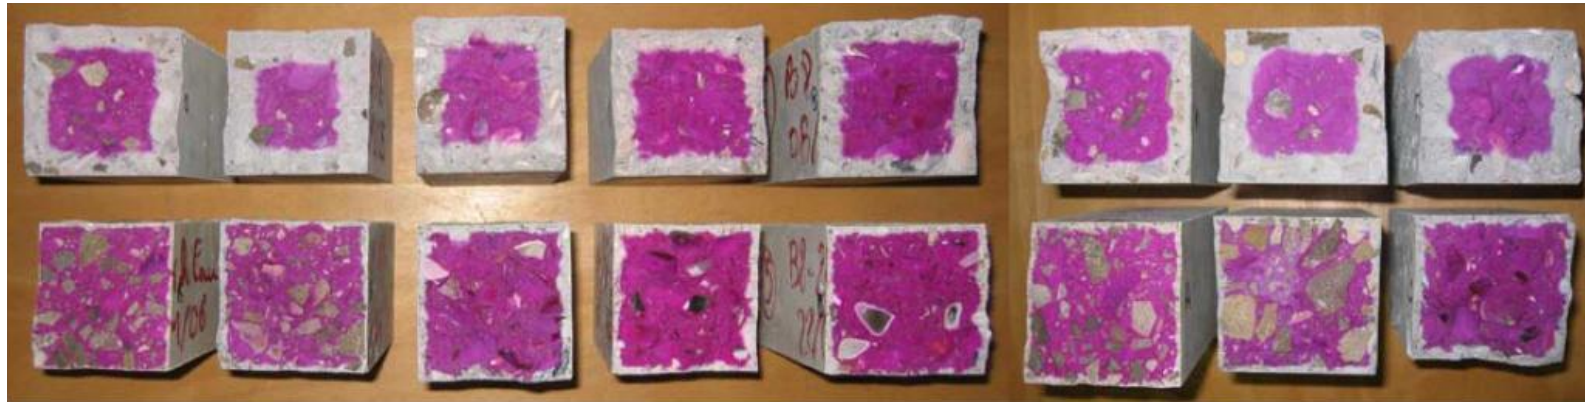
Poses a new (old) problem that had become negligible with CEM I, that is **corrosion of the reinforcement due to carbonation**

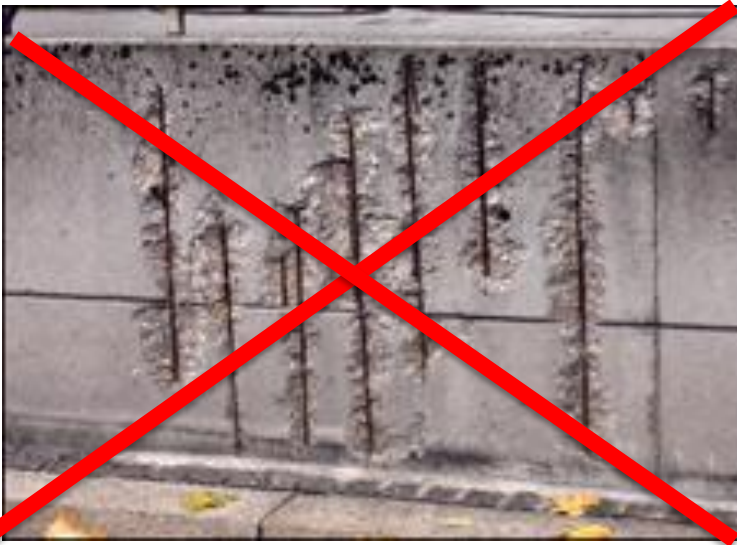
Choose a more corrosion resistant reinforcement

Iron 12% chromium alloy (Fe 12%Cr) is passive at pH 7 (without concrete....)

**Corrosion is completely avoided** (even at very low cover depths)

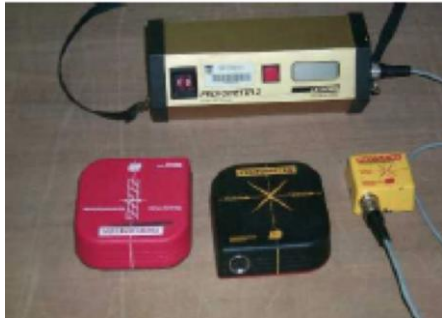
Cover depth

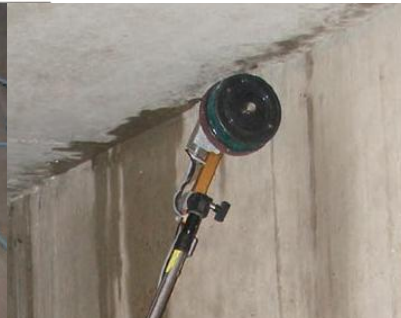
Half-cell potential
