THEME III

SEISMIC BEHAVIOUR OF STRUCTURAL CONCRETE TWO-DIMENSIONAL
ELEMENTS (SHEAR WALLS AND OTHERS)

NON-LINEAR ANALYSIS OF REINFORCED CONCRETE SHEAR WALLS

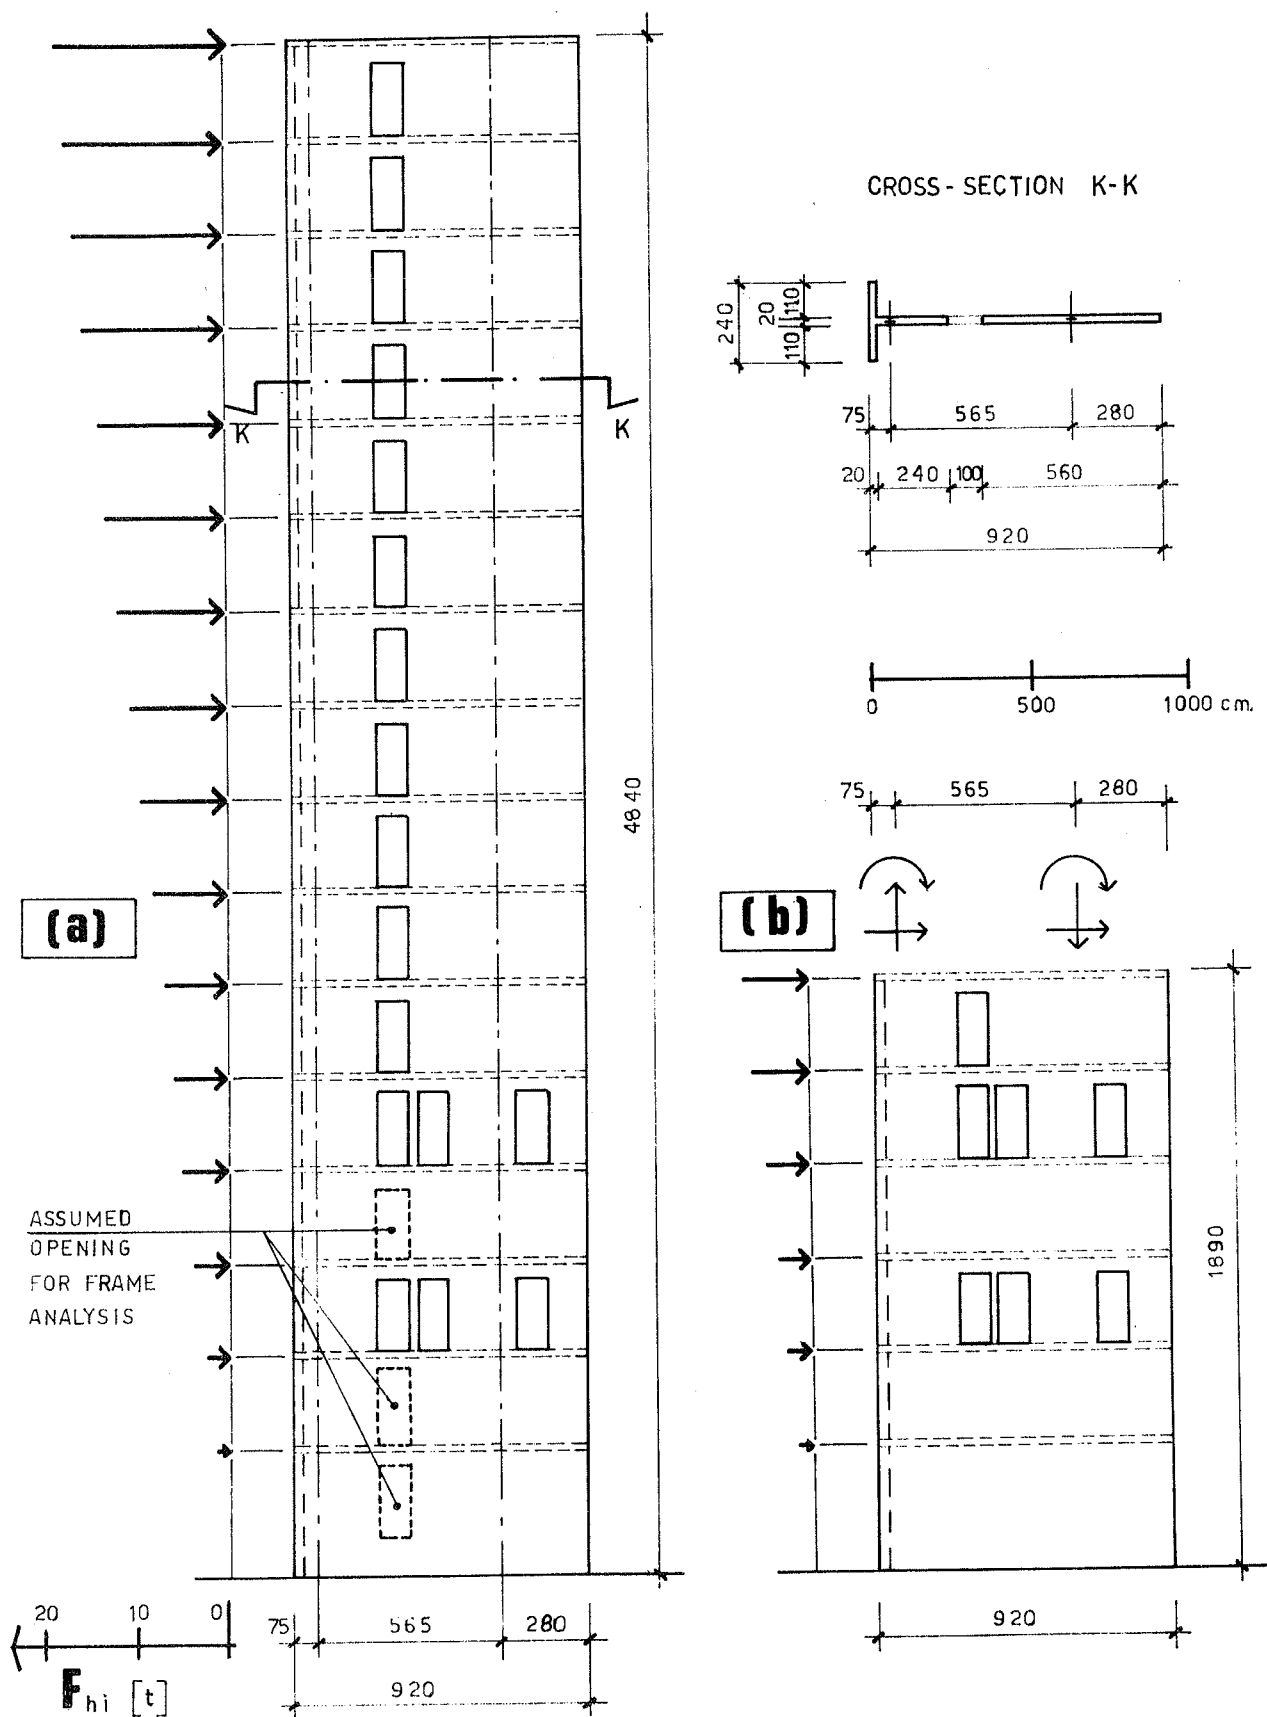
Fig. 1

— (a) Actual shear wall and idealized frame;
 (b) bottom part, analyzed with finite elements.

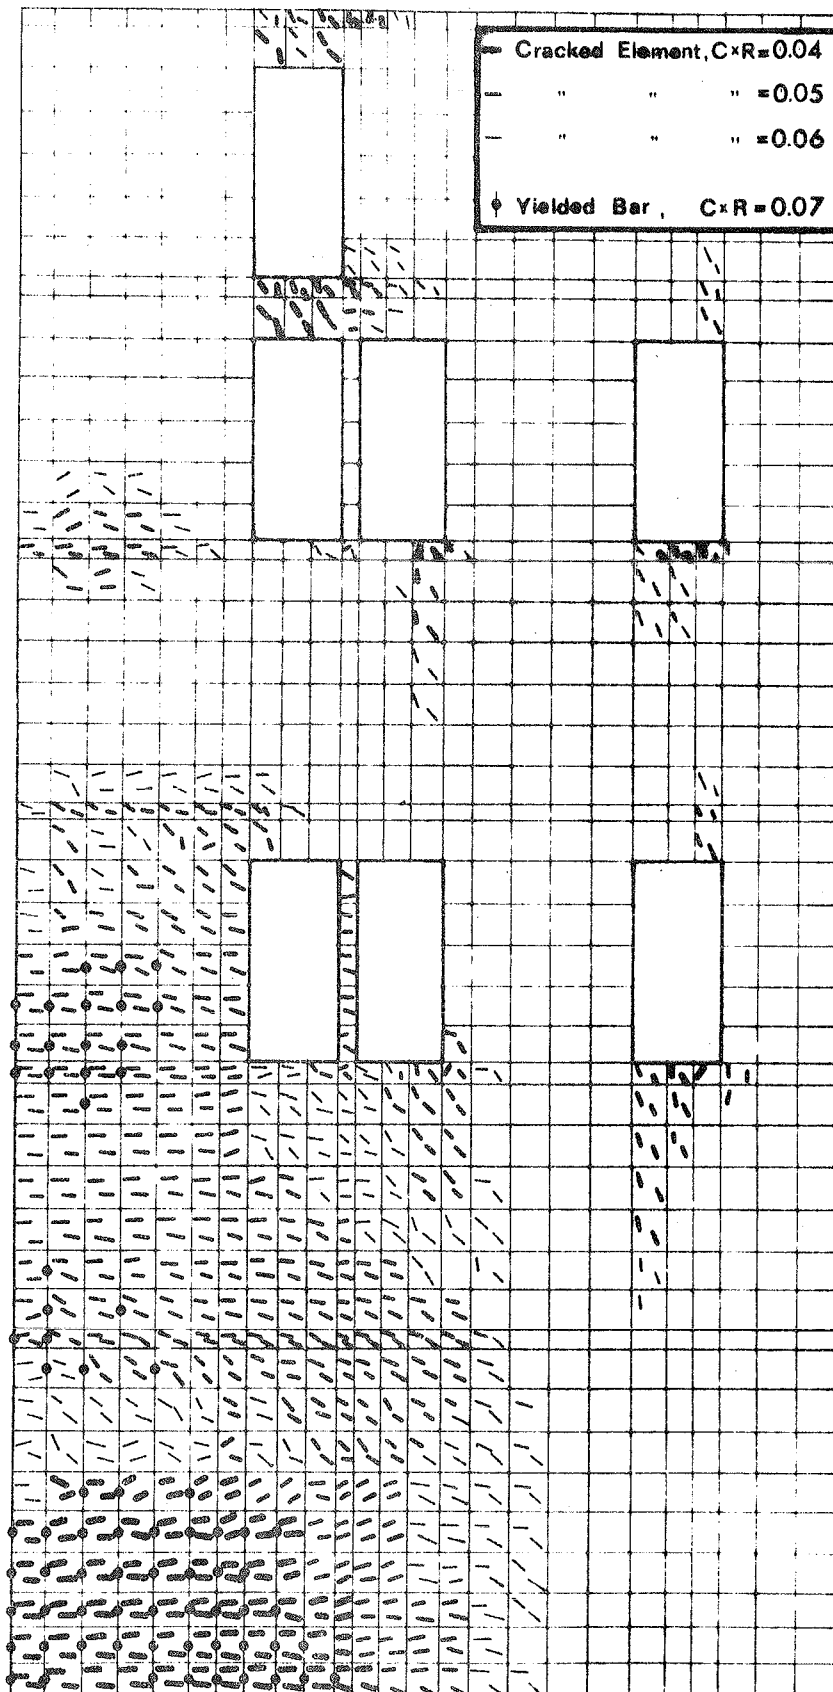
- Crack distribution
 for lateral forces
 corresponding to
 $C \times R = 0.06$

Fig. 2 shows the direction of crack propagation for the various load increments resulting from the analysis. The cracks which are initially horizontal are caused by the flexural action, and subsequently slant showing the effect of shear. On the same figure is shown the position of yielded bars under the effect of lateral forces corresponding to $C \times R = 0.07$, at which the wall fails.

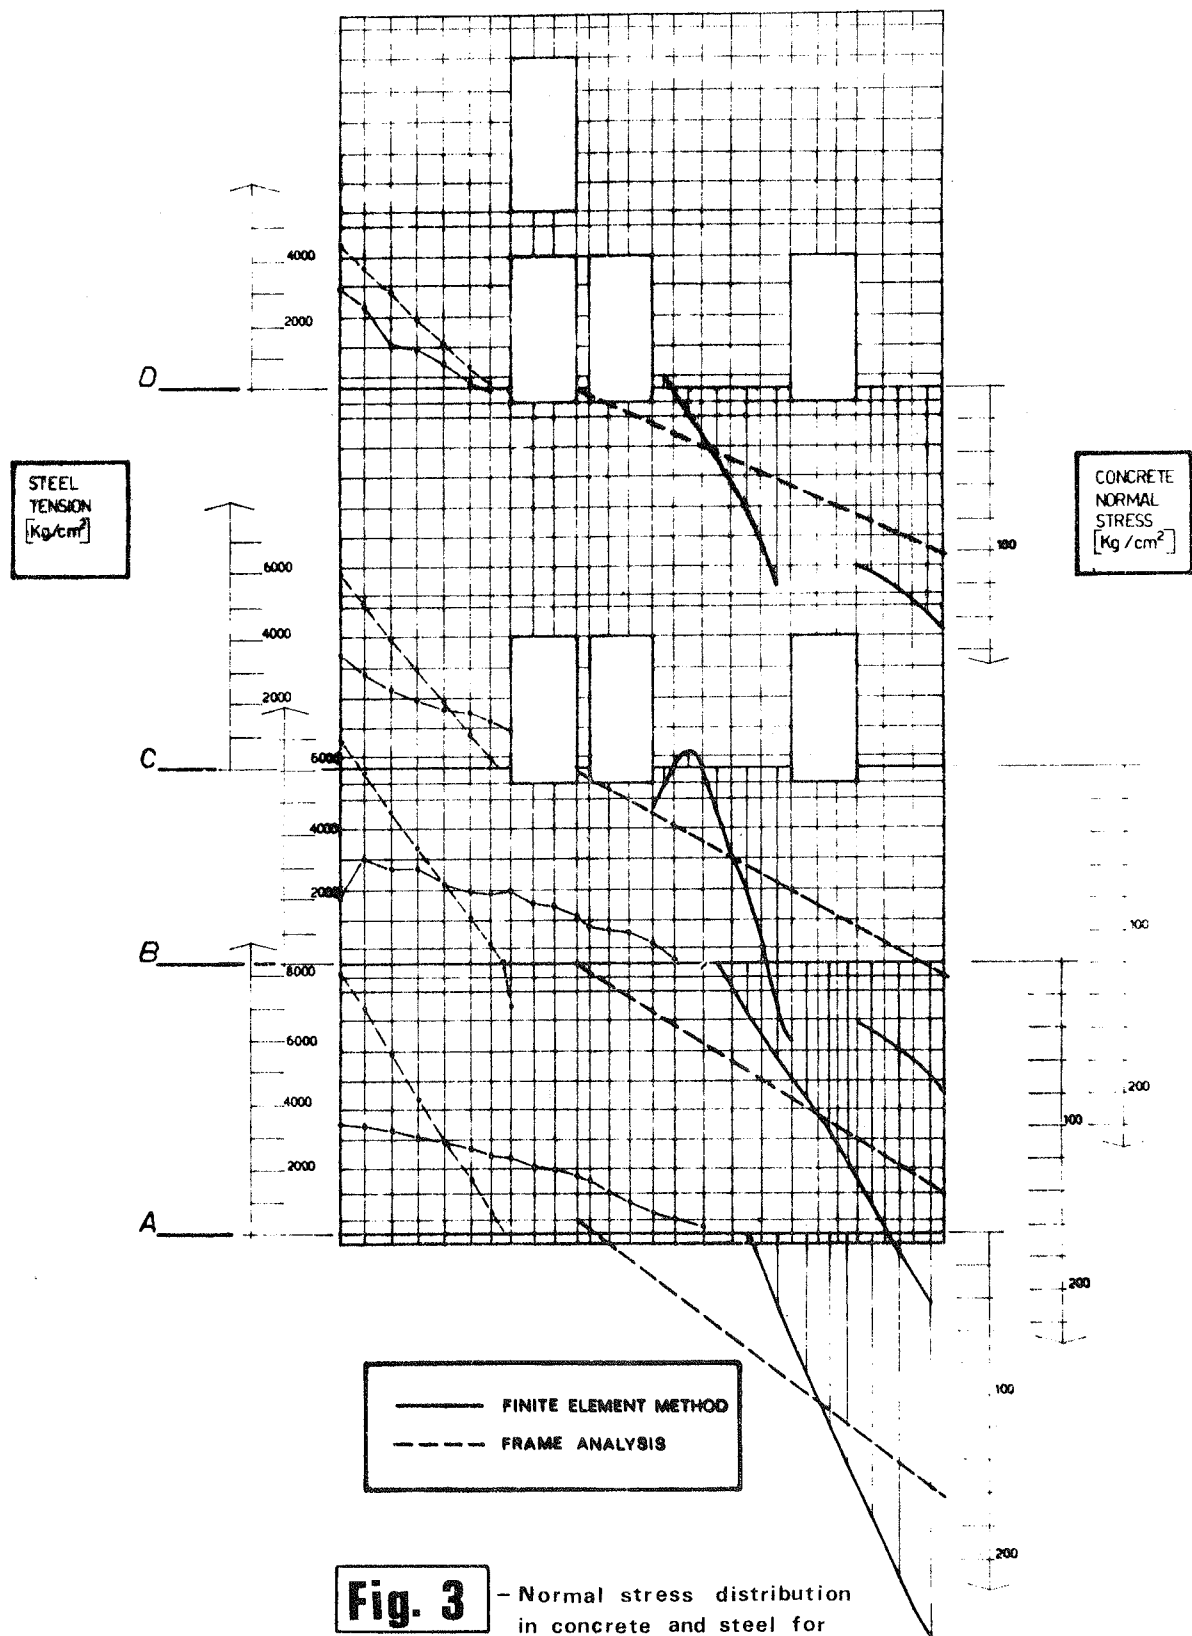
Fig. 3 - Normal stress distribution in concrete and steel for lateral forces corresponding to $C \times R = 0.06$

Fig. 3 shows the distribution of normal stresses in the vertical direction, in concrete and steel. The effects of the irregular distribution of the openings and of concrete cracking are evident, especially if compared to the distribution obtained with a linear analysis.

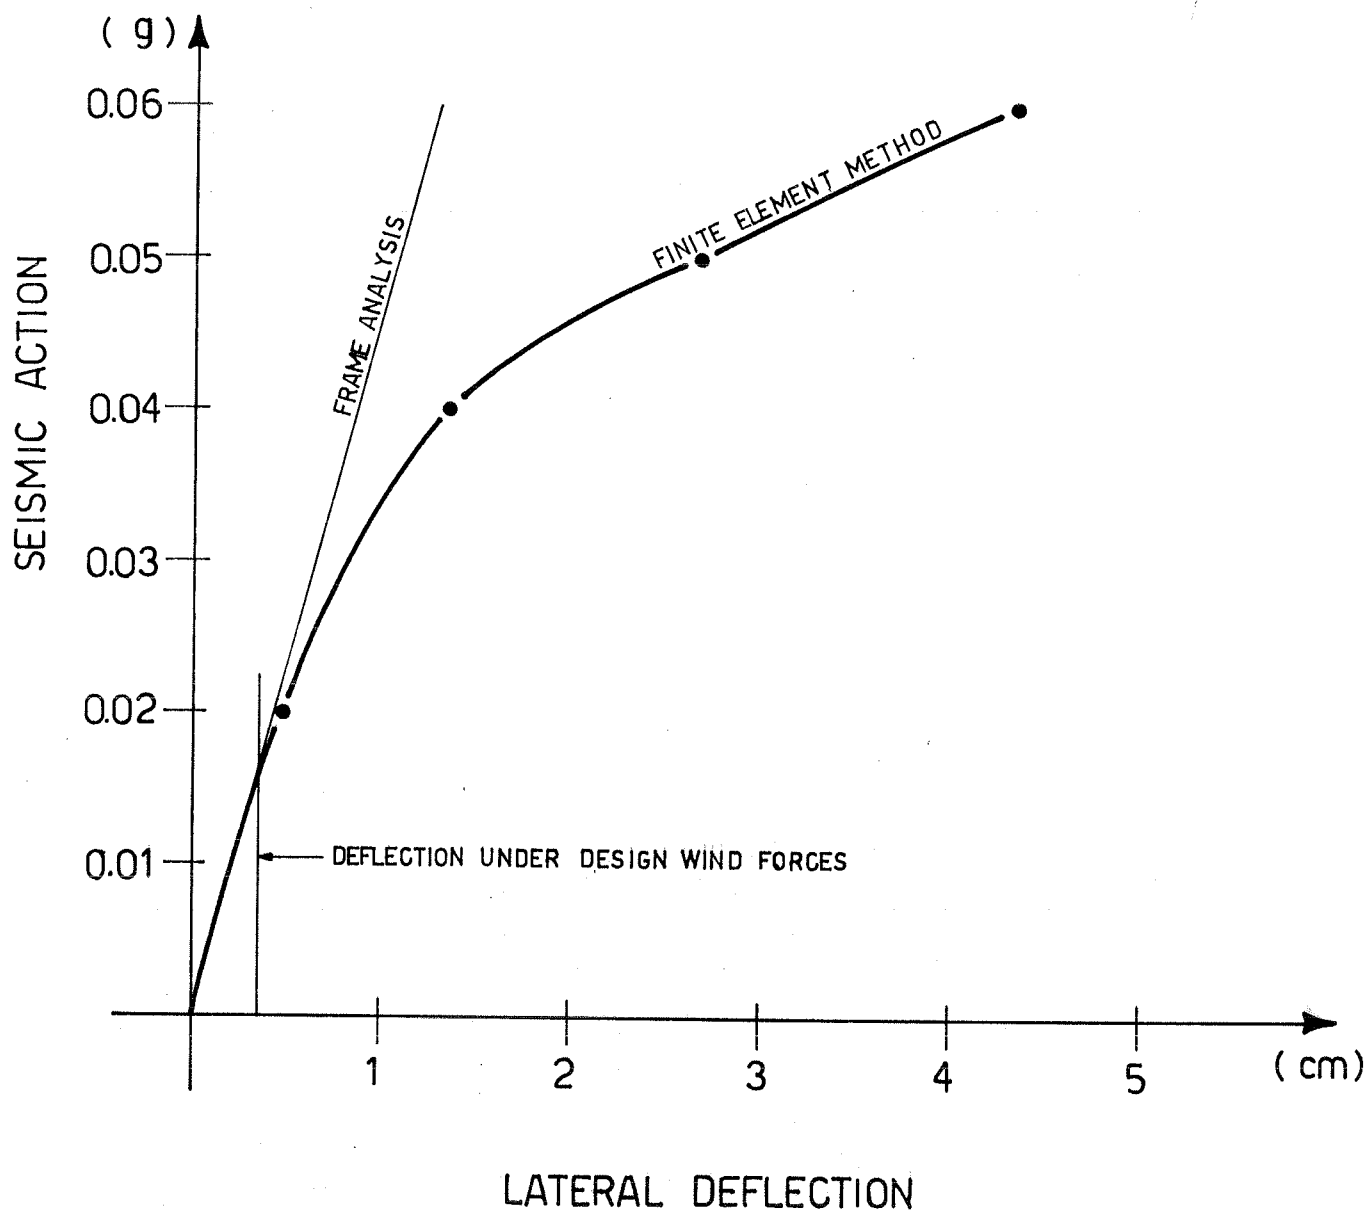
- Lateral deflection of the top of the bottom part of the shear wall for increasing values of lateral forces

Fig. 4 shows the lateral deflection at the top of the bottom part of the shear wall for increasing values of earthquake forces. One can notice the sharp bend in the curve when cracking starts. For the sake of comparison, on the same drawing are represented the deflections calculated with frame analysis, and the deflection due to design wind load, calculated with finite element analysis.

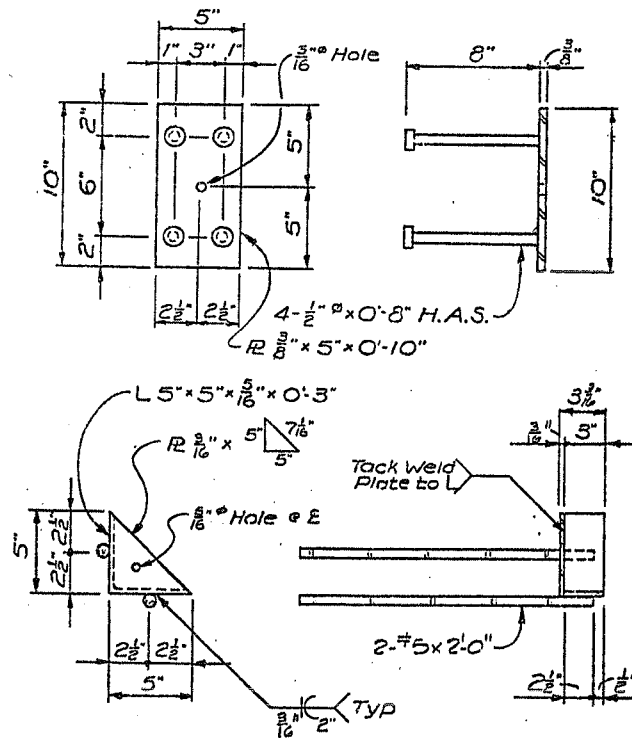
FIGURE 1 -- PLATES P-3 (TOP) AND P-8 (BOTTOM)

The P-8/P-3 combination is a standard connection used in horizontal joints. The ultimate capacity was substantially larger than the previously rated capacity of 14.9K. In test "a", hairline cracks initiated around the studs in P-3 at a shear force of 35.7 kips. When the force reached 37 kips brittle weld failure occurred. In test "b", however, a large slip occurred at a level of 35K (due to compression bearing spalling) followed by a high residual force. In both tests no cracks or signs of distress showed up around P-8.

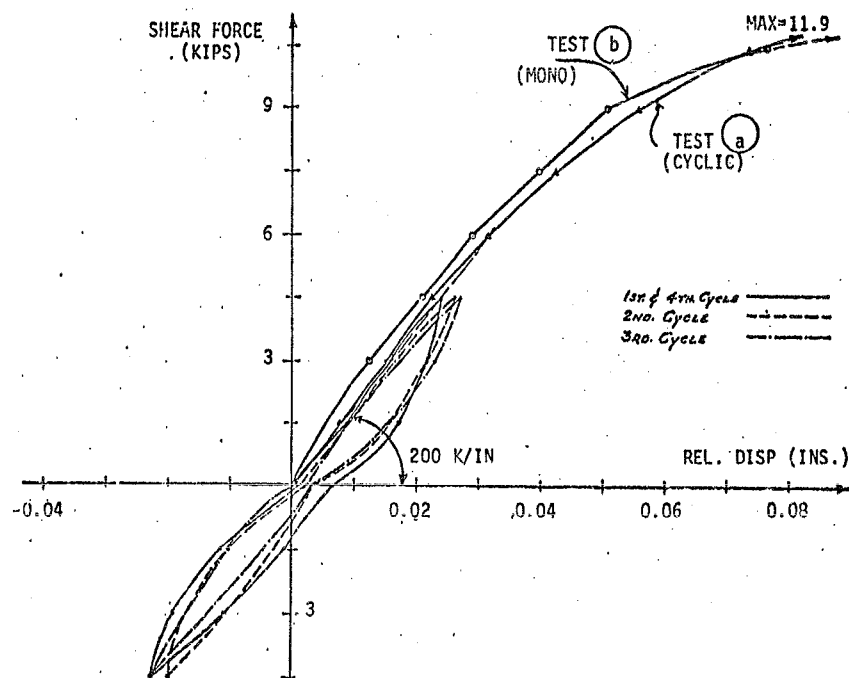
FIGURE 2 -- CYCLIC BEHAVIOR OF D-34/D-34 COMBINATION

Connection D-34 exhibited a brittle failure at 11.9 kips. This was due to the lack of "truss action" by the rebars. Although the failure load was about double the previous recommended ultimate strength, it was decided to change the design so that the bars will be placed at an angle of 60° with the tee edge as detailed. This connection is being used in vertical joints.

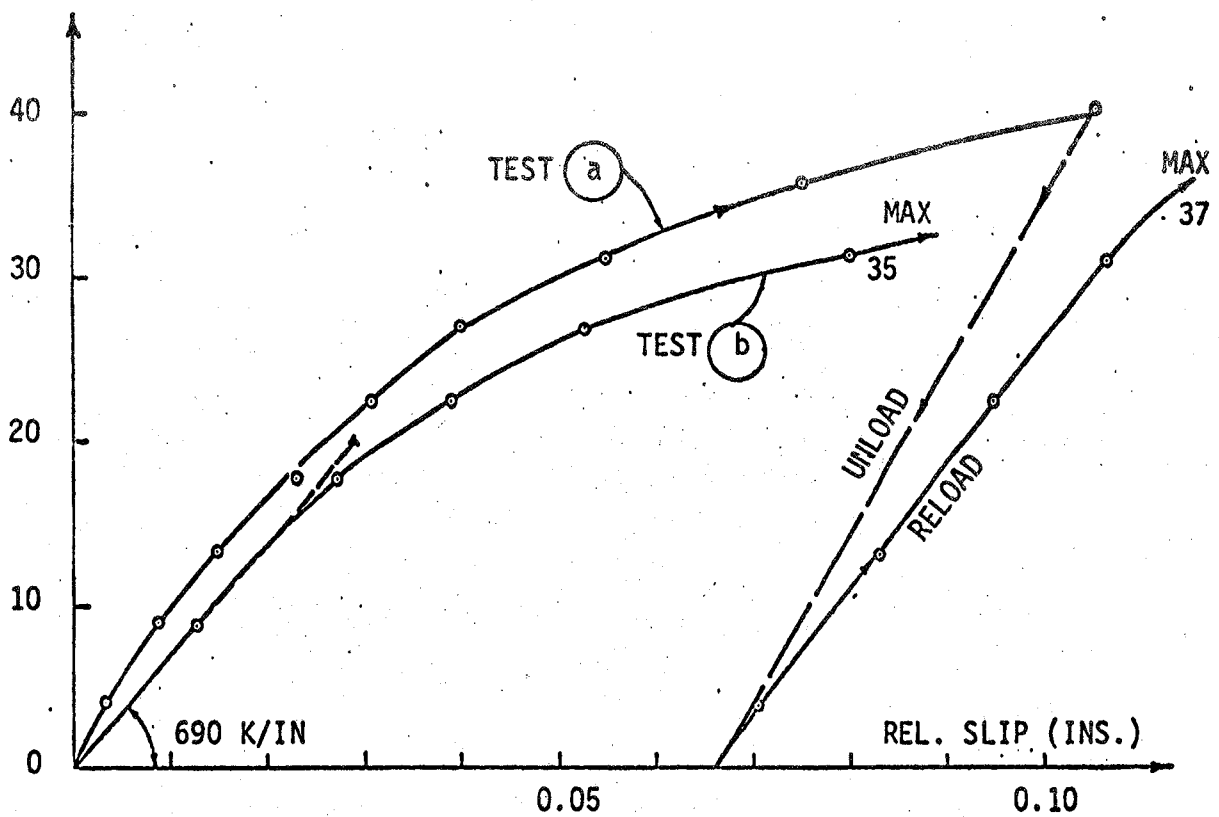
FIGURE 4 -- SHEAR FORCE VS. SLIP FOR P-8/P-3 COMBINATION

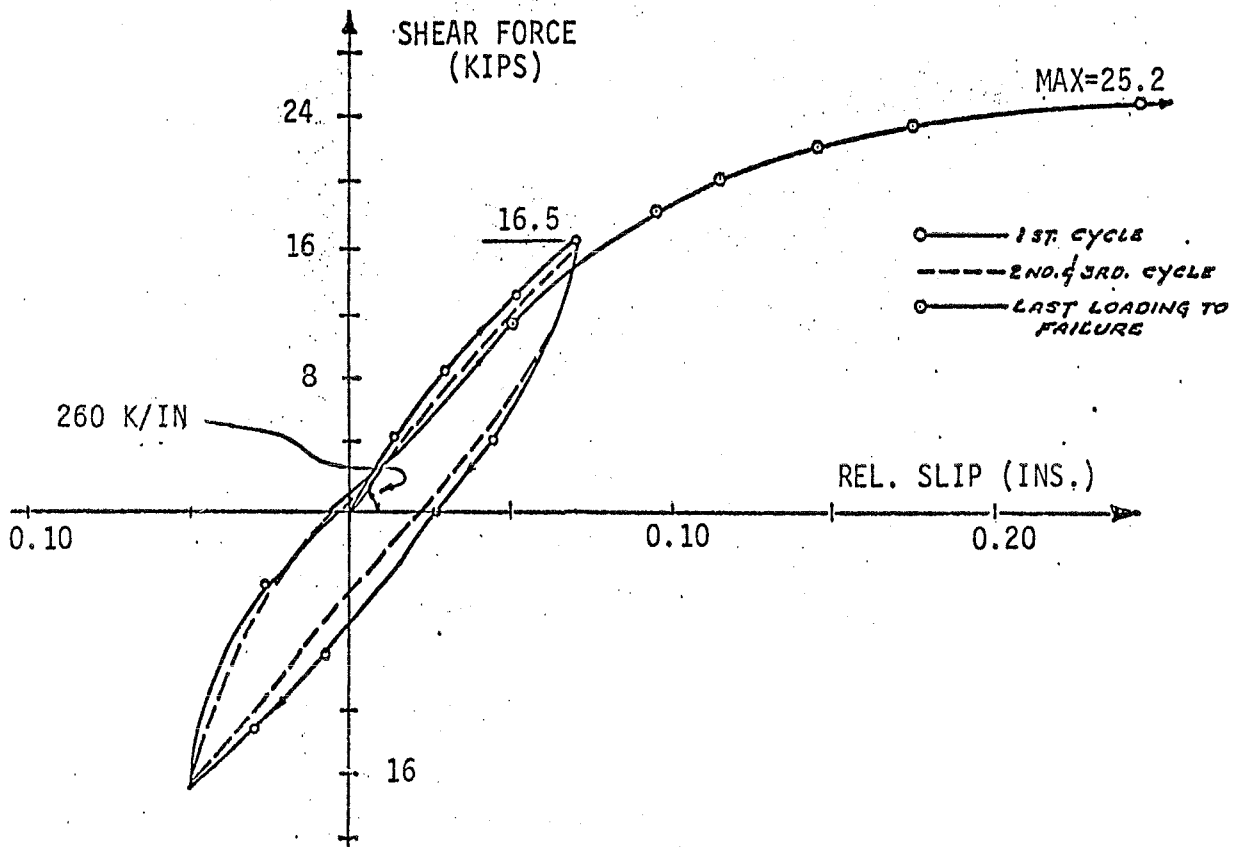
FIGURE 6 -- CYCLIC SHEAR VS. SLIP FOR P-9/P-9 COMBINATION

The P-9/P-9 combination is widely used in vertical joints. Several premature weld failures occurred when undersize field weld plates (2"x3") were intentionally tried. 3" x 4" x 3/8" weld plates allowed the monotonic failure load to reach 32.7K. Under cyclic loading ($P_0 = 16.5K$), no cracks appeared and maximum load attained was 25.2K when weld failure occurred. In the last test the weld plate was bent to accommodate a 1/2" elevation difference.

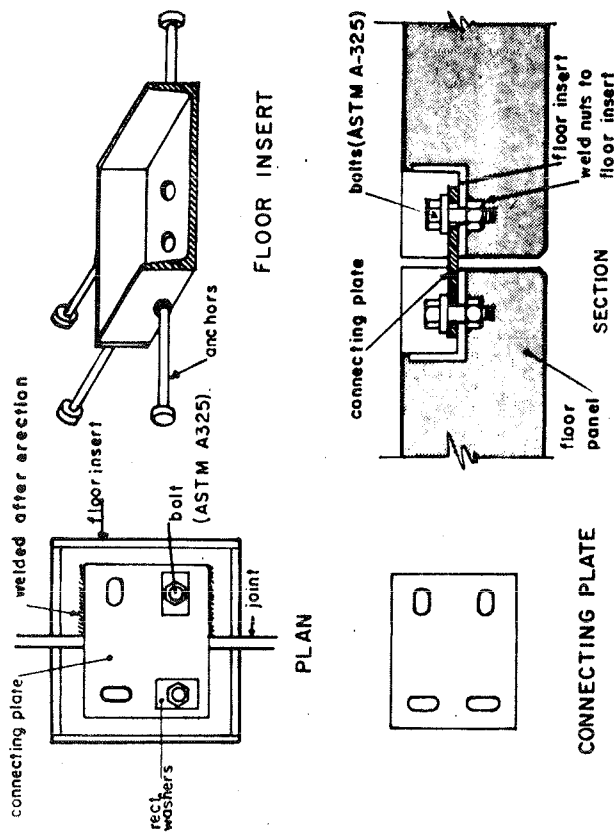
FIG. 1 FLOOR-TO-FLOOR-OR WALL-TO-WALL JOINT

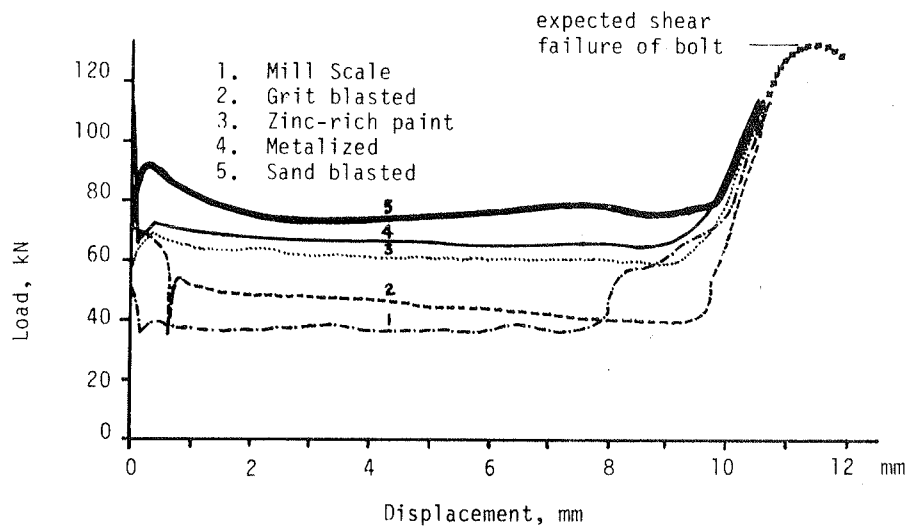
FIG. 5 LOAD DISPLACEMENT CURVE, WALL-TO-WALL JOINT

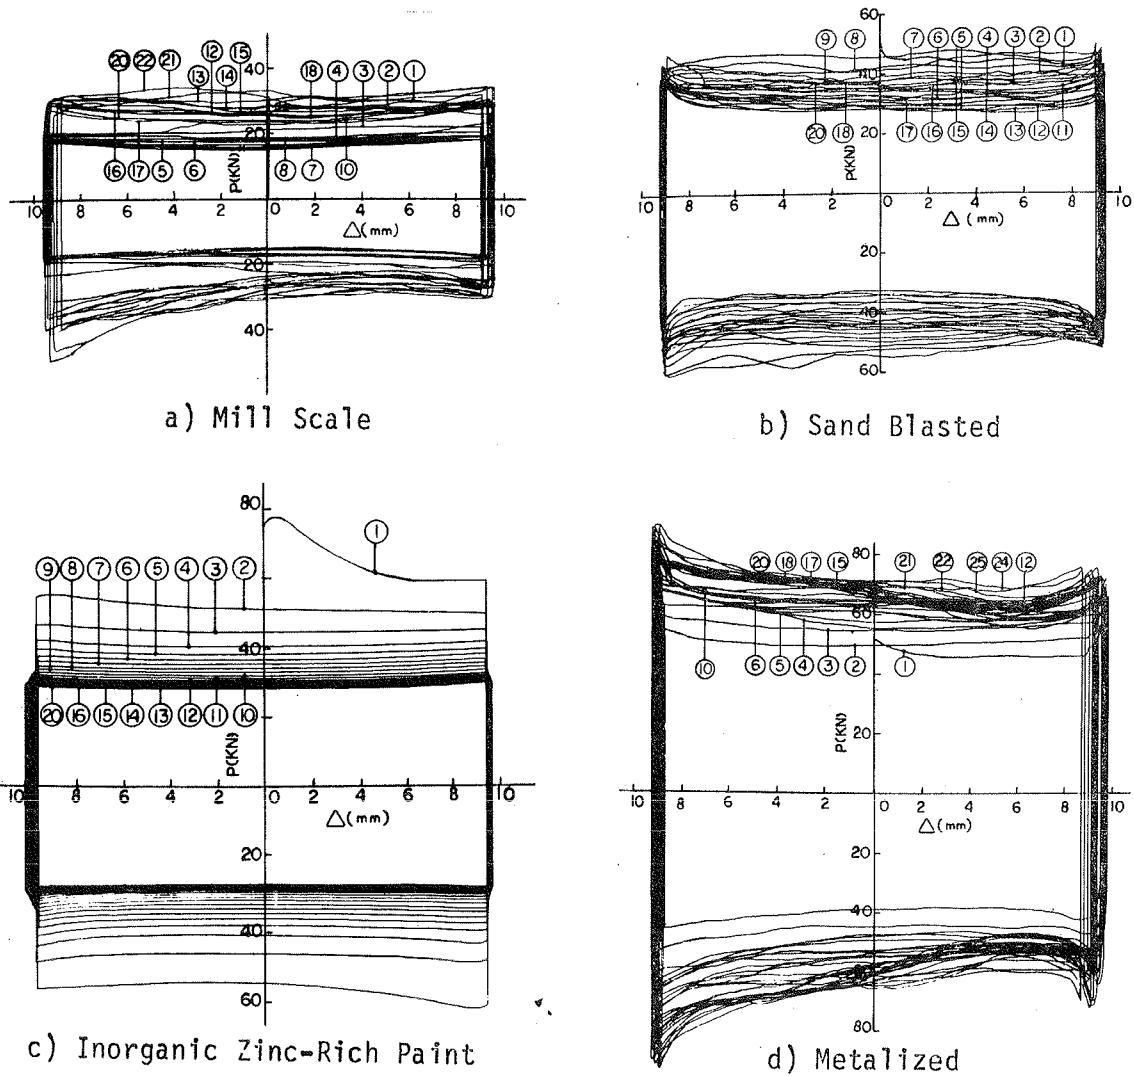
FIG. 6 HYSTERESIS LOOPS, WALL-TO-WALL JOINT

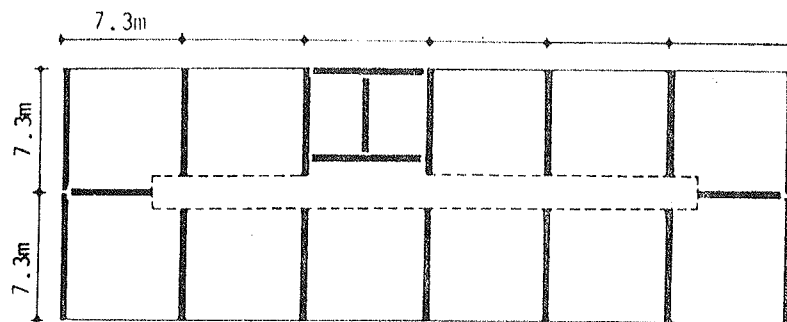
FIG. 7 TYPICAL PANELIZED BUILDING

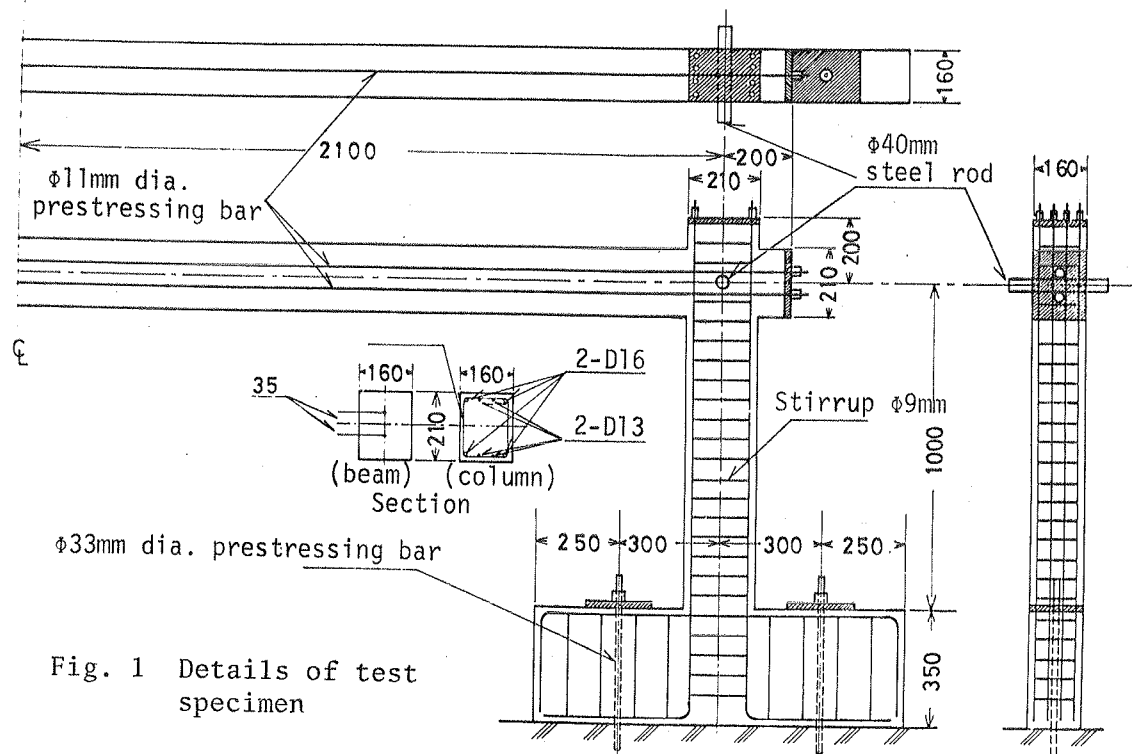
Fig. 1 Details of test specimen

Two portal frame specimens were tested by applying the lateral load. The frame of 4.2 m long and 1 m high consists of prestressed concrete beam and ordinary reinforced concrete columns as shown in Fig. 1. The dimensions of cross section are 16 cm in width and 21 cm in depth for both prestressed concrete beam and ordinary reinforced concrete columns. Throughout the whole length of beam, uniformly distributed prestress was transferred into the concrete section by 2- $\phi 11$ mm dia. prestressing steel bars. The column was reinforced by 4-D16 mm and 4-D13 mm dia. ordinary deformed bars with $\phi 9$ mm dia. closed stirrups in a pitch of 6.5 cm. The reinforcements in columns were anchored mechanically on the top surface to prevent the slippage of reinforcement from beam-column joint. Mechanical properties of prestressing steel bar and ordinary reinforcements are listed in Table 1.

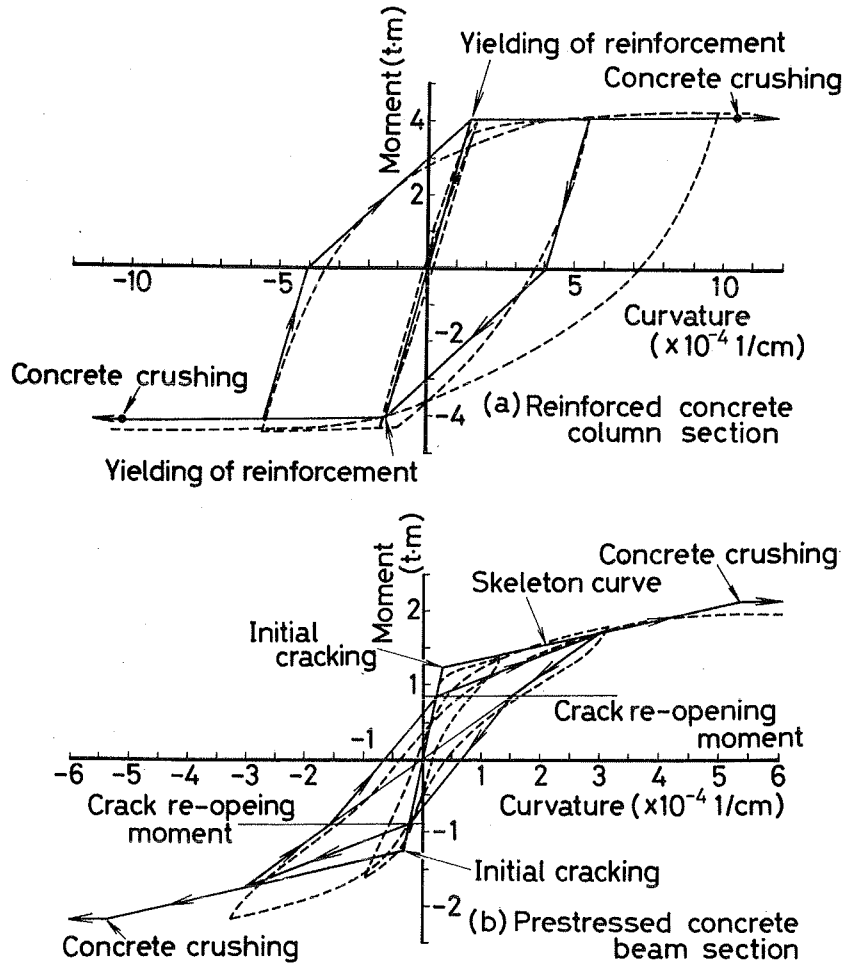
Fig. 2 Measured and idealized moment-curvature relations of constituent member sections.

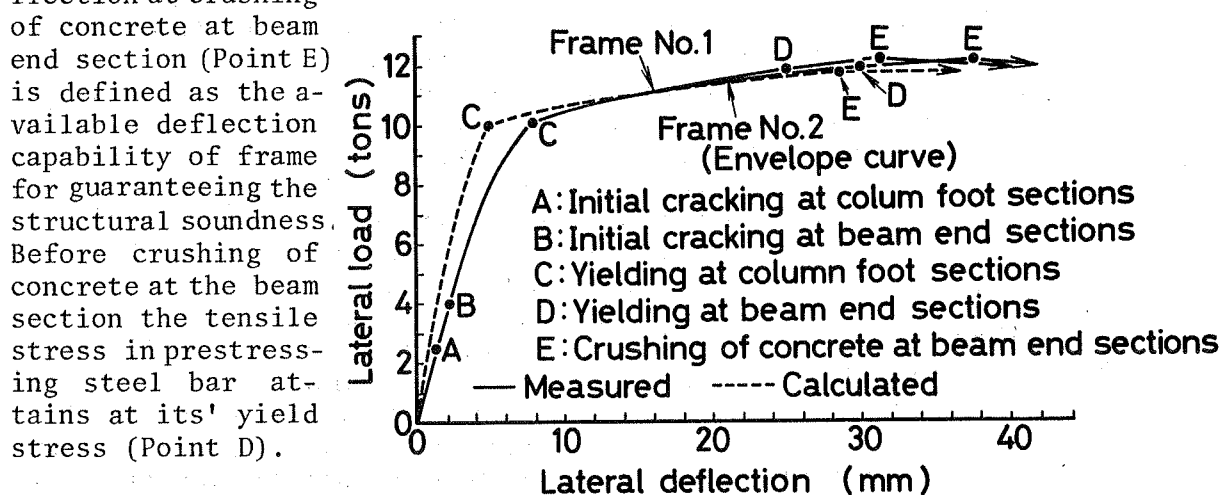
Fig. 3 Measured and calculated lateral load-deflection skeleton curves of frame

In Fig. 3, lateral load-deflection skeleton curve measured from Frame No. 1 is illustrated by solid line. The initial flexural crack took place at both column foot sections at the lateral load of 2.25 tons (Point A in Fig. 3) and followed at both end sections of beam at 4 tons (Point B). When applied load is 10.1 tons, the yielding took place at both column foot sections (Point C) and after that the large elasto-plastic lateral deformation was observed because of the formation of plastic hinge at column foot sections. At the load of 12.3 tons the crushing of concrete took place at both end sections of beam (Point E) and the frame becomes failure mechanism with considerable post-crushing plastic deformation. Thus, in this study, the deflection at crushing

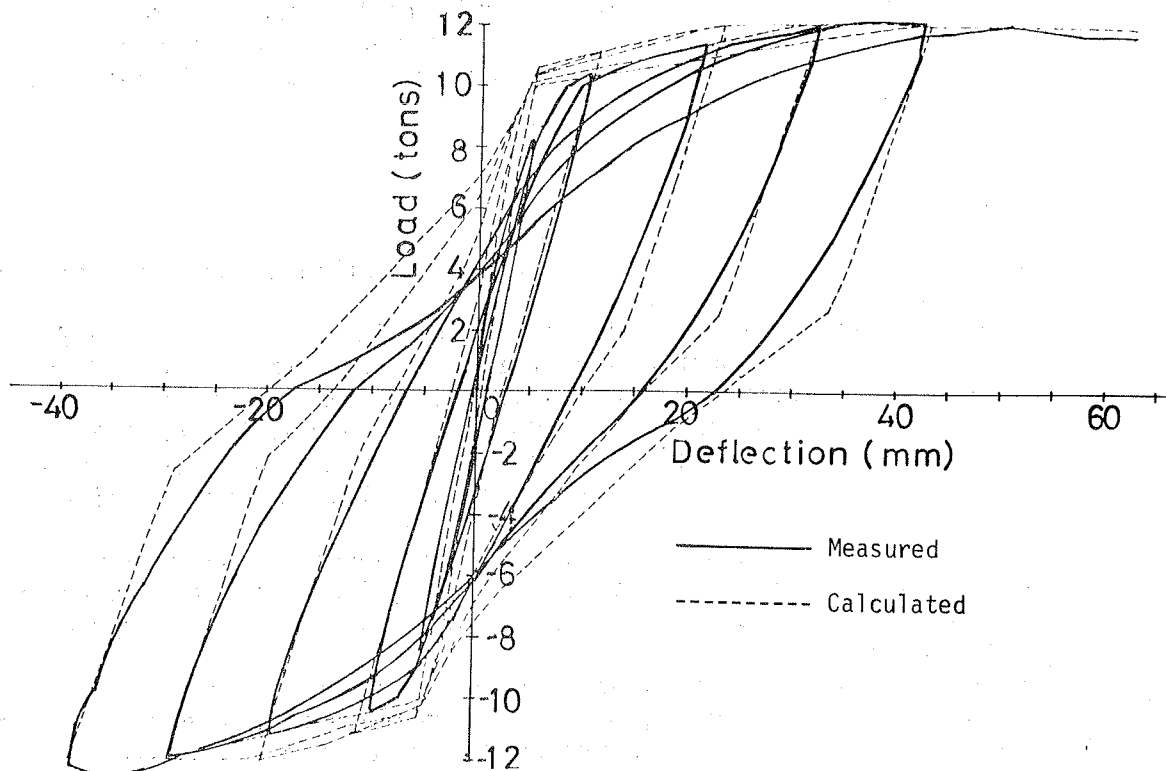
Fig. 4 Measured and calculated lateral load-deflection hysteresis loops on Frame No. 2

In Fig. 4, lateral load-deflection hysteresis curve obtained from reversed cyclic loading tests on Frame No. 2 is shown by solid line. As can be seen from Fig. 4, good spindle shaped hysteresis loops with large energy dissipation capability are observed. In this study, the reinforcements in column of frame specimen were anchored mechanically on the top surface of column for preventing the bond slippage of reinforcements from beam-column joint. This may results in the good spindle shape in hysteresis loops.

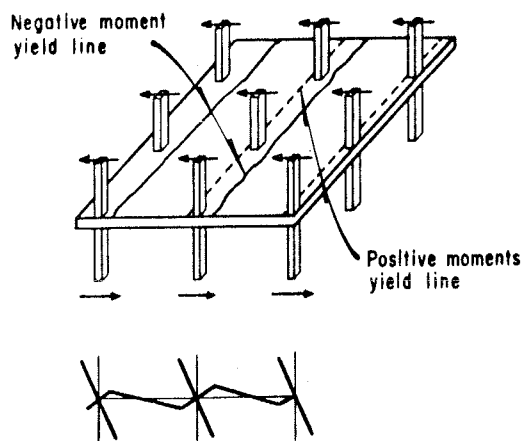
Fig 1. Mechanism of collapse due to bending failure

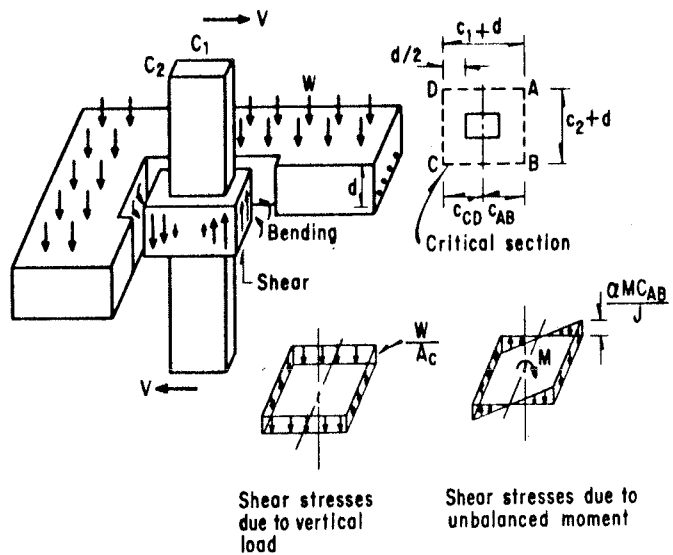
Fig 2. Shear stresses in the critical section according to the ACI-77 code

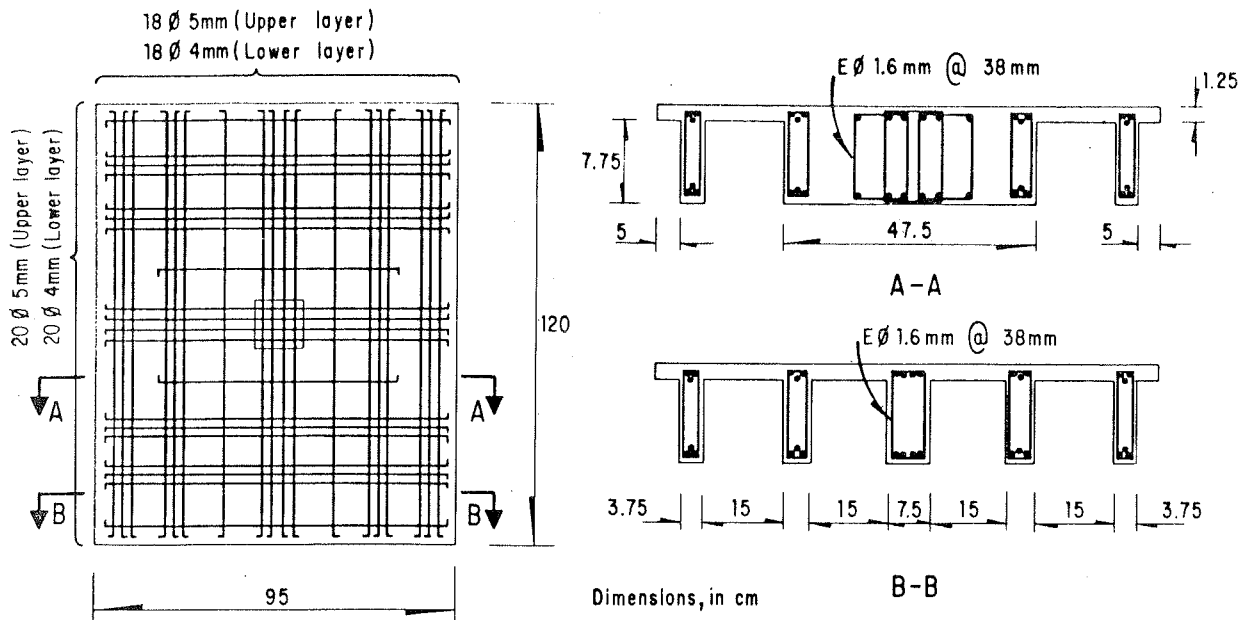
Fig 5. Arrangement of reinforcement (Specimen E3)

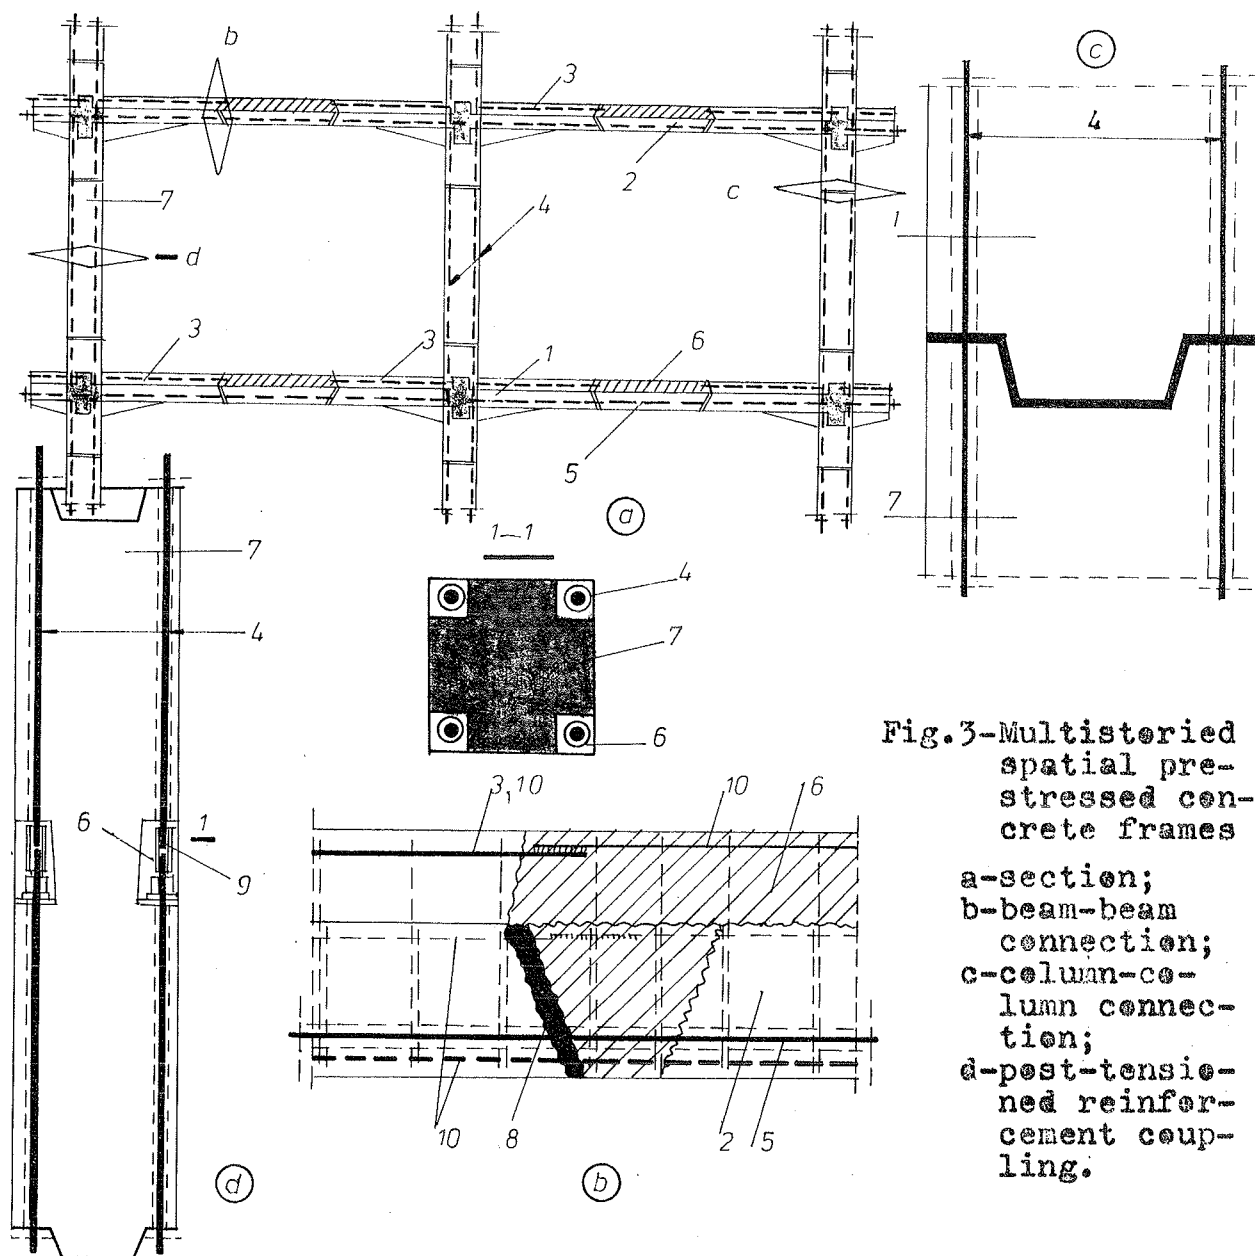
Fig.3-Multistored spatial prestressed concrete frames

a-section;
b-beam-beam connection;
c-column-column connection;
d-post-tensioned reinforcement coupling.

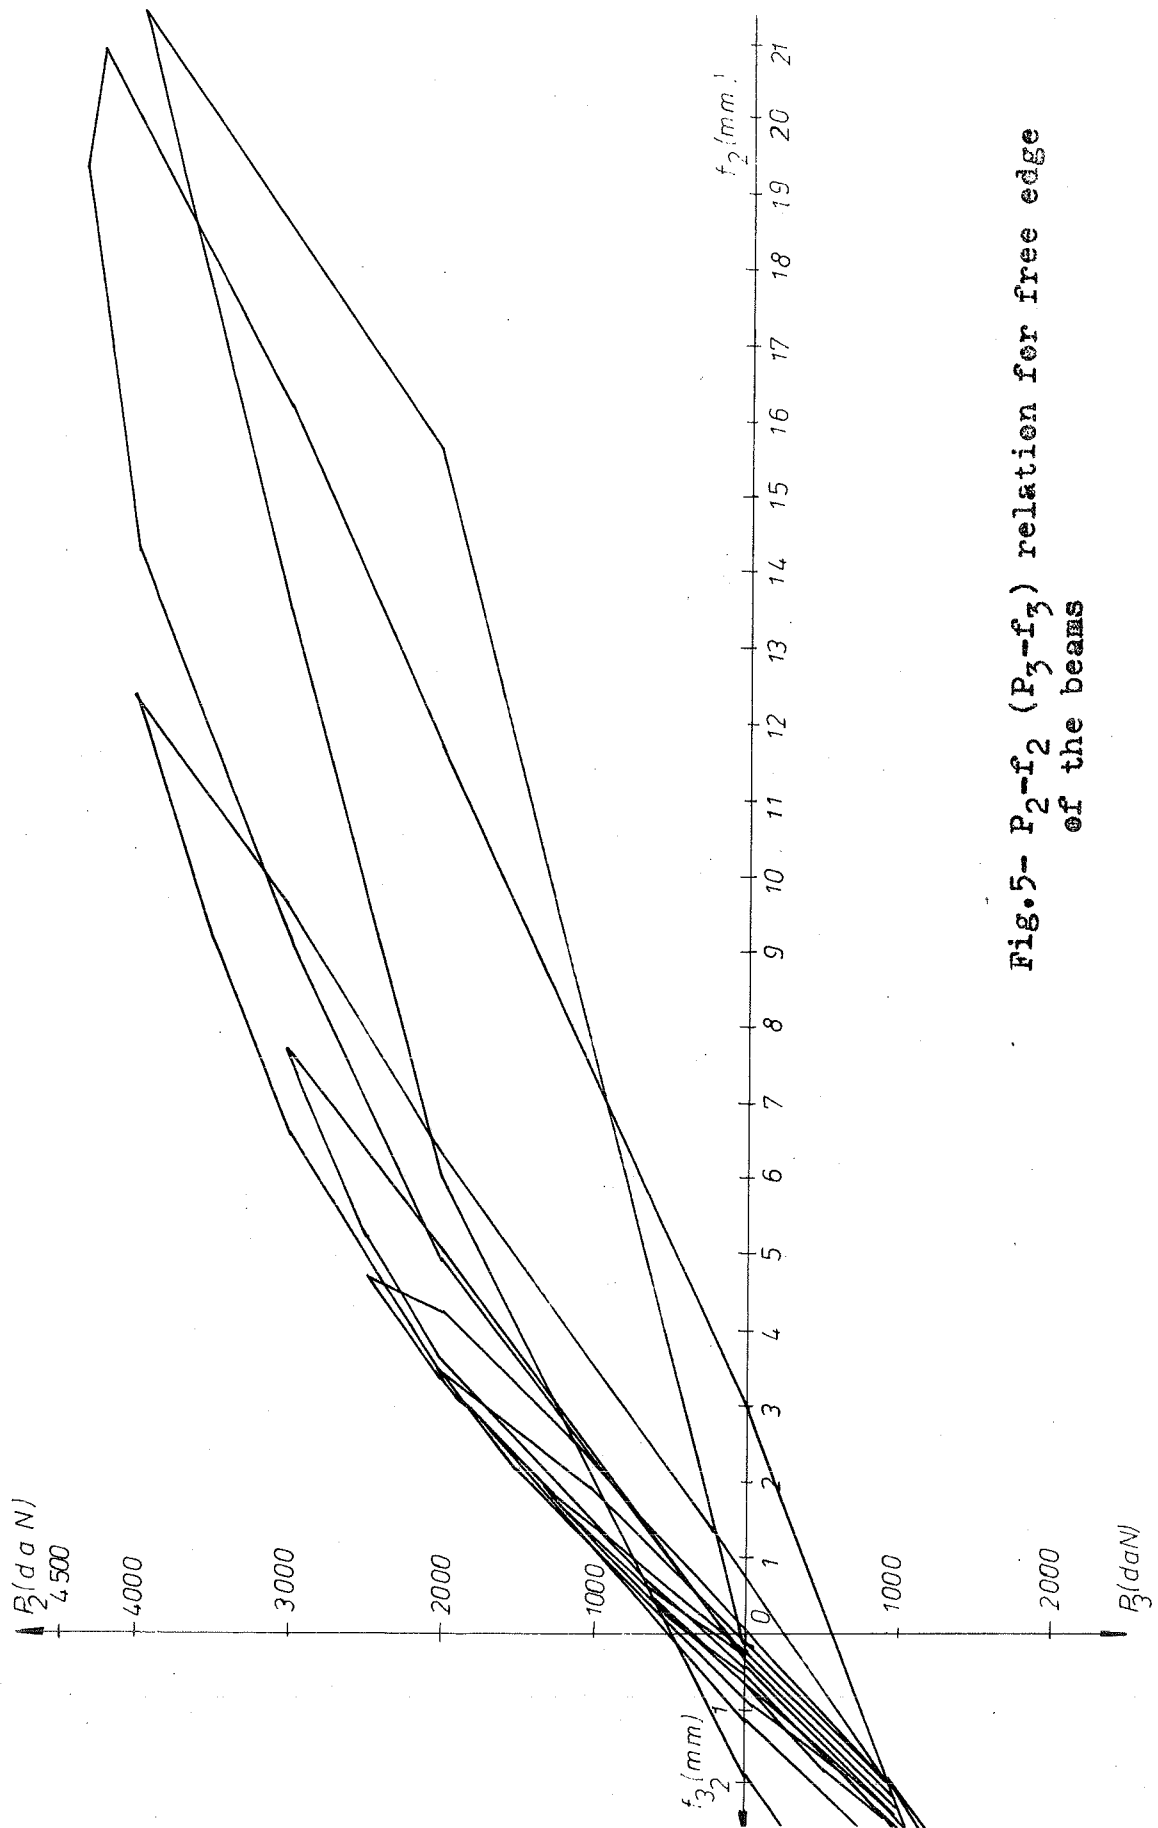
Fig.5- P_2 - f_2 (P_3 - f_3) relation for free edge
of the beams

The obtained results, expressed in free displacements of the lightweight concrete beam-ends, the assembly displacements in the connecting area of the post-tensioned bars into the columns, as well as the strains in column-column joints, are presented in fig.5; 6, 7; the draft of final crackings is presented in fig.8.
