THEME III

SEISMIC BEHAVIOUR OF STRUCTURAL CONCRETE TWO-DIMENSIONAL
ELEMENTS (SHEAR WALLS AND OTHERS)

NON-LINEAR ANALYSIS OF REINFORCED CONCRETE SHEAR WALLS

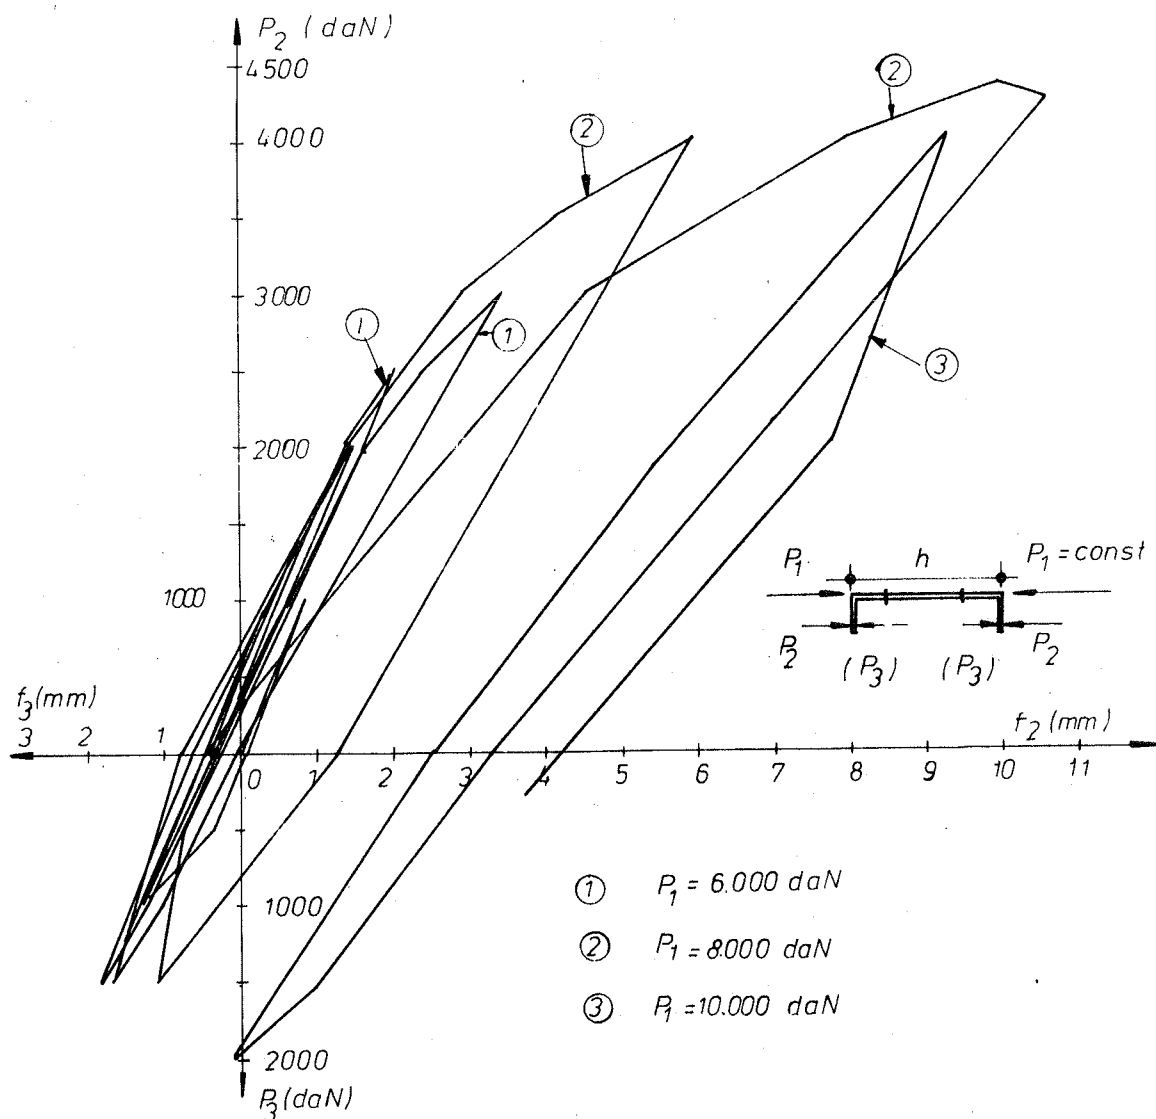
Fig.6- P_2-f_2 (P_3-f_3) relation in middle height section of the experimental assembly

The obtained results, expressed in free displacements of the lightweight concrete beam-ends, the assembly displacements in the connecting area of the post-tensioned bars into the columns, as well as the strains in column-column joints, are presented in fig.5; 6, 7; the draft of final crackings is presented in fig.8.

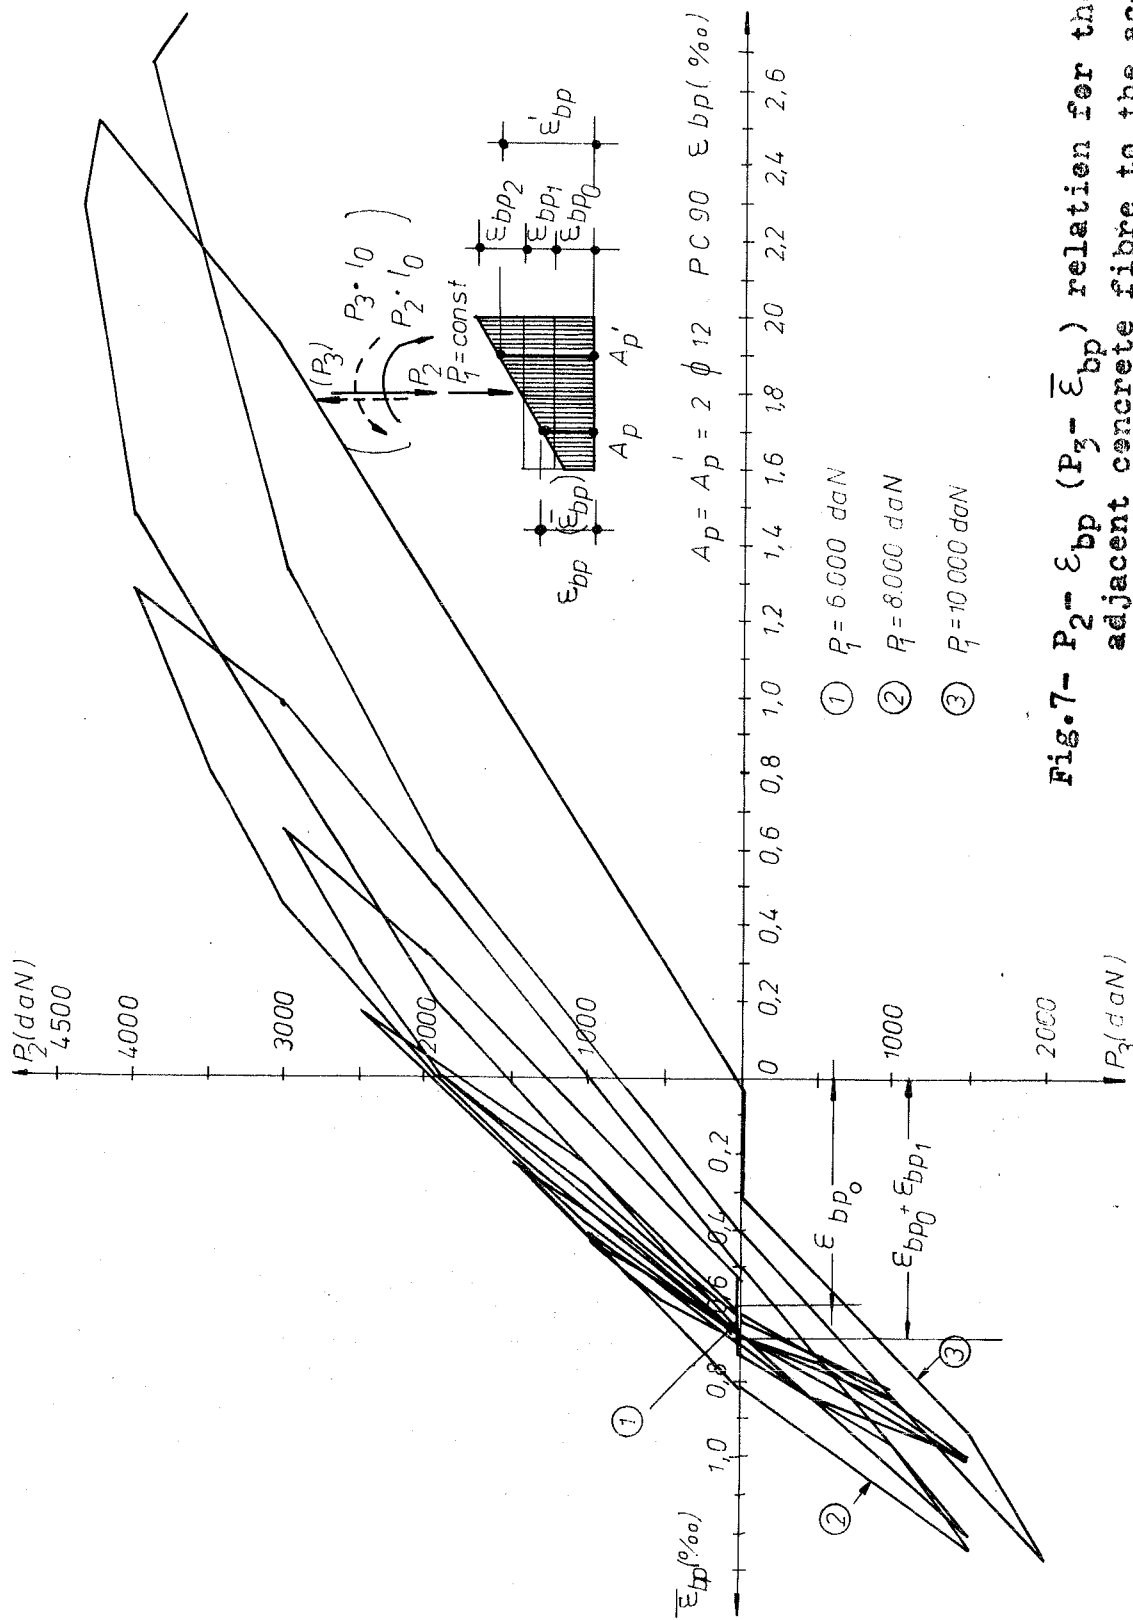
Fig.7- $P_2 - \epsilon_{bp}$ ($P_3 - \epsilon_{bp}$) relation for the adjacent concrete fibre to the active reinforcement A_p , in the column-column connection

By analysing the experimental results that are synthesised in the $P-\Delta$ and $P-\varepsilon$ curves respectively one finds a good behaviour of the experimental assemblies, of the column-column joints and of the coupling areas of post-tensioned bars respectively; a total continuity is realised into the joinings alongside the assuring of some corresponding ductilities.

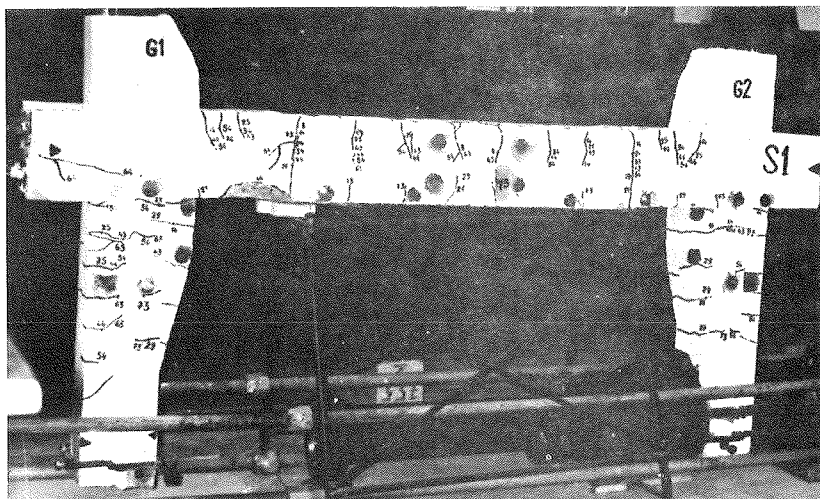
Fig.8- General view of the experimental assembly after failure

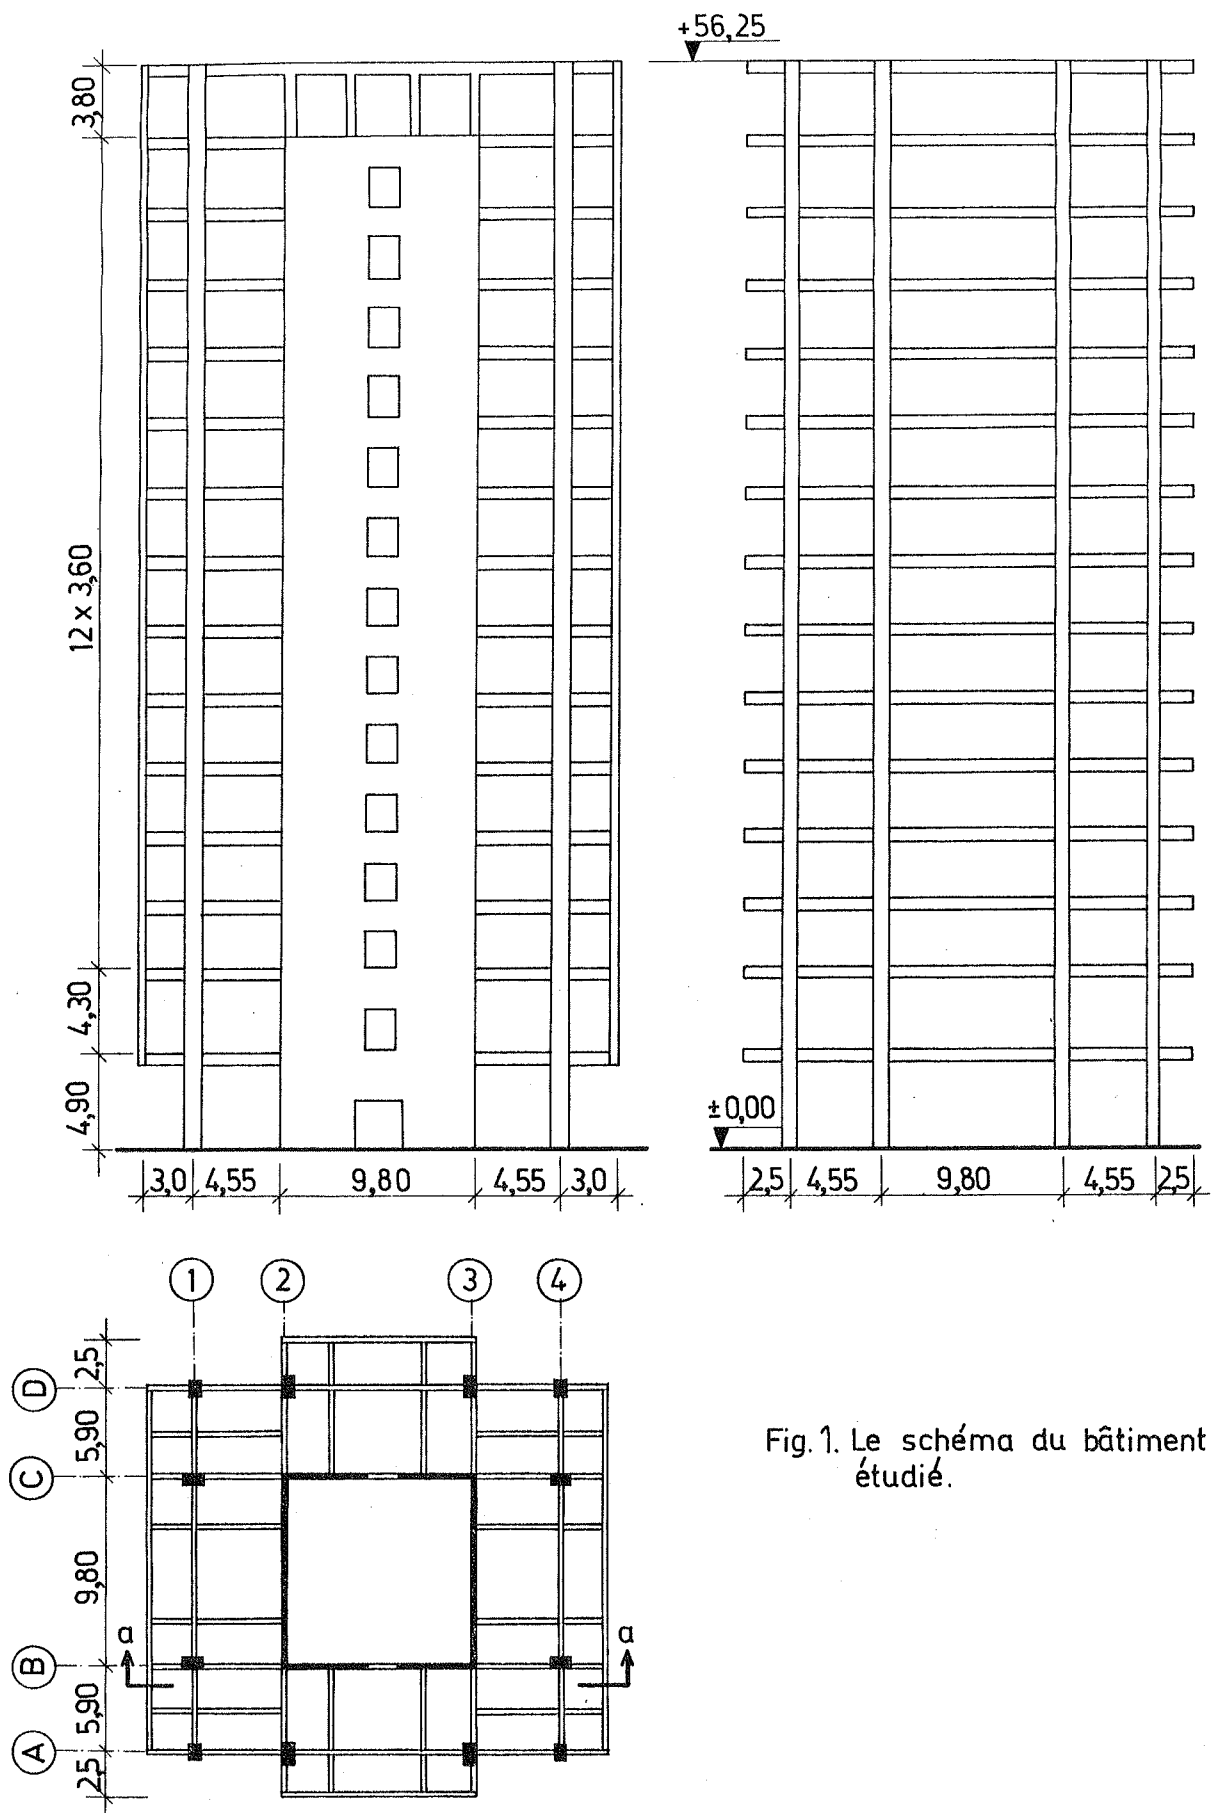
Fig.1. Le schéma du bâtiment étudié.

Dans la figure 1 on représente le schéma constructif du bâtiment administratif à 15 niveaux exécuté à Bucaresti - Roumanie en 1965 et avec l'ossature en béton armé monolithe constituée d'un noyau central en diaphragmes verticales et des partiques périphériques dont le comportement au séisme 4.03. 1977 a été étudié. L'analyse a été faite à l'aide d'un programme, mis au point pour l'analyse élastique des structures mixtes dans le domaine élastique [Olariu, 1978:4]. Le programme, écrit en langage FORTRAN, a été vérifié, en testant un modèle d'une ossature à 11 niveaux [Negoită, Olariu 1978:2]. Le modèle mathématique des axes B et C du bâtiment est présenté dans la fig. 2

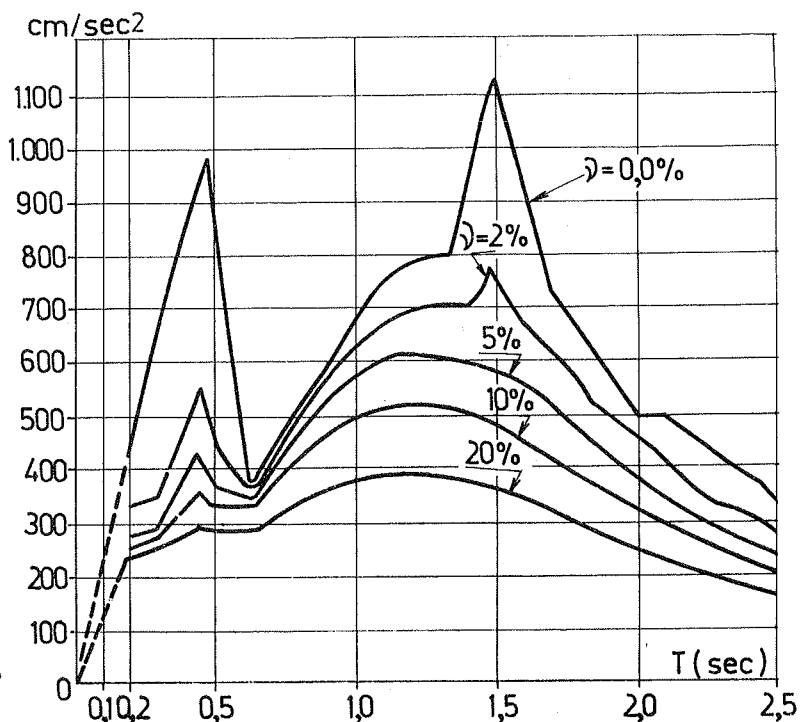
Fig. 3. Le spectre des accélérations du séisme de 4 mars 1977.

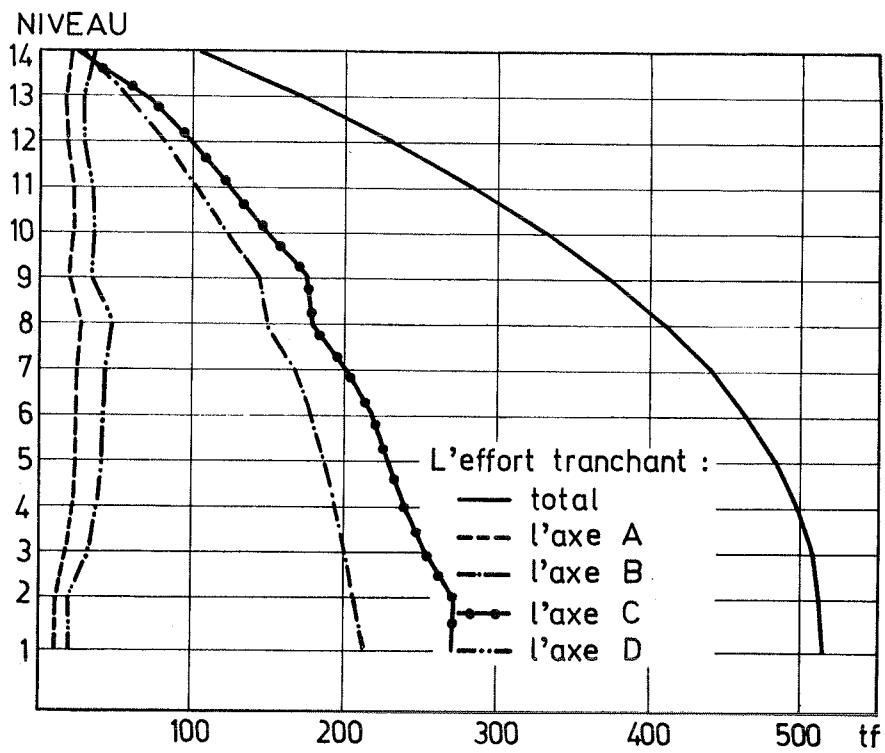
Fig. 5. La répartition de l'effort tranchant entre les éléments résistants verticaux.

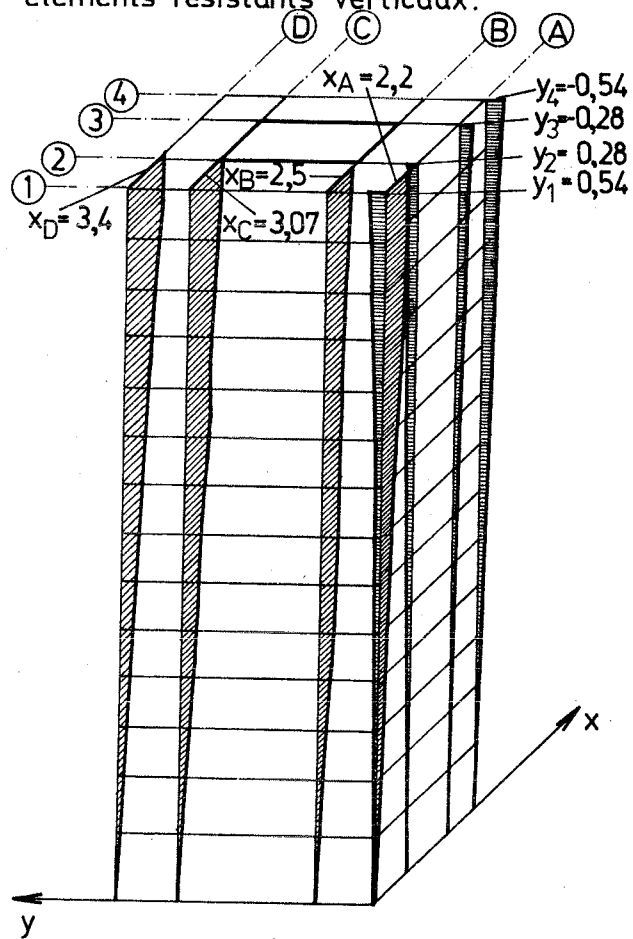
Fig.6. Les déplacements latéraux théoriques de l'ossature.

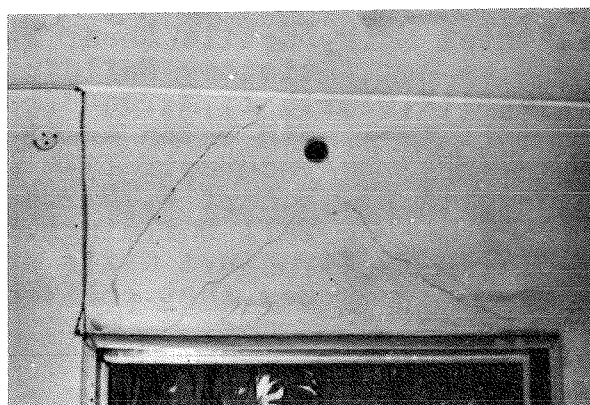
NIVEAU 2.(b)

FIG.8. La fissuration des linteaux.

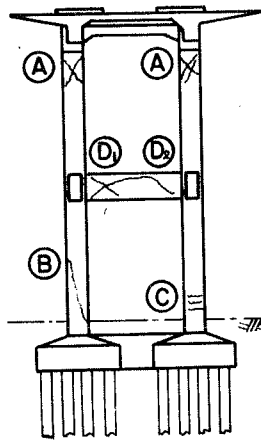
Fig. 2-1
Crack patterns
of Rigid Frame
Viaduct

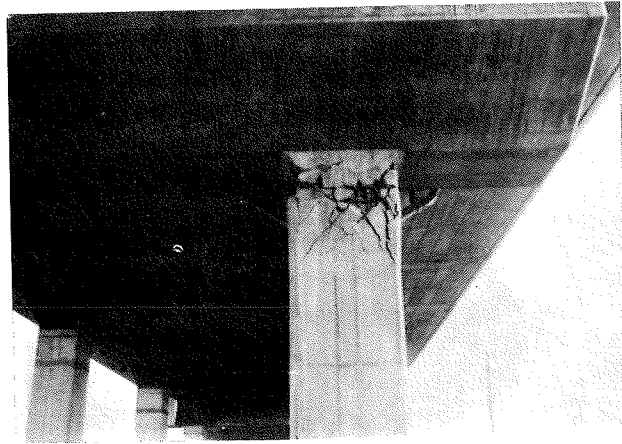
Fig. 2-2 Damage at the Top of Column

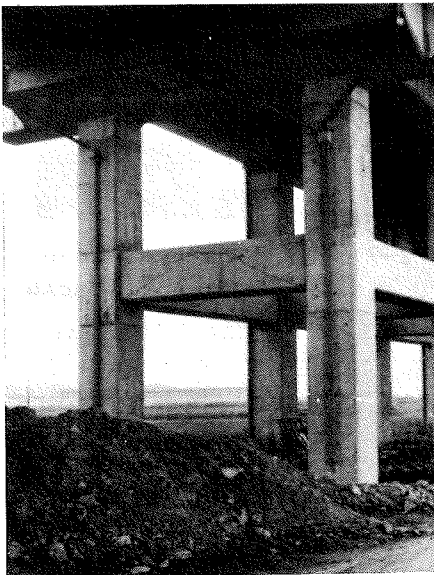
Fig. 2-3 Cracks of Cross
Beam

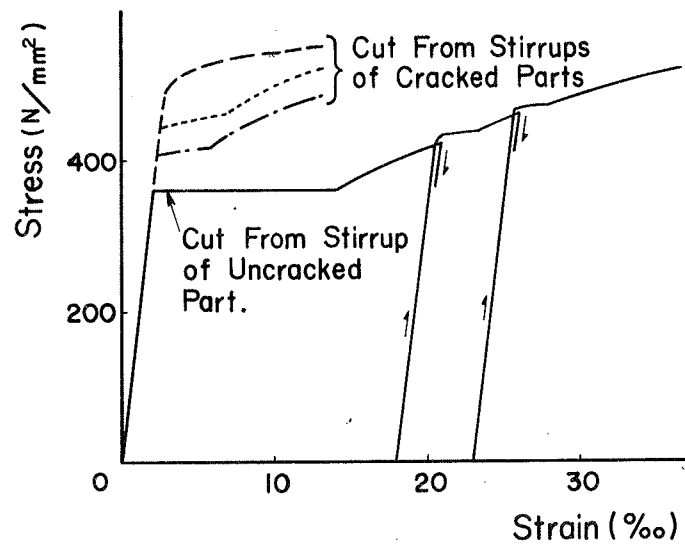
Fig. 2-4 σ - ϵ Diagrams of Reinforce-
ment Cut from Stirrups

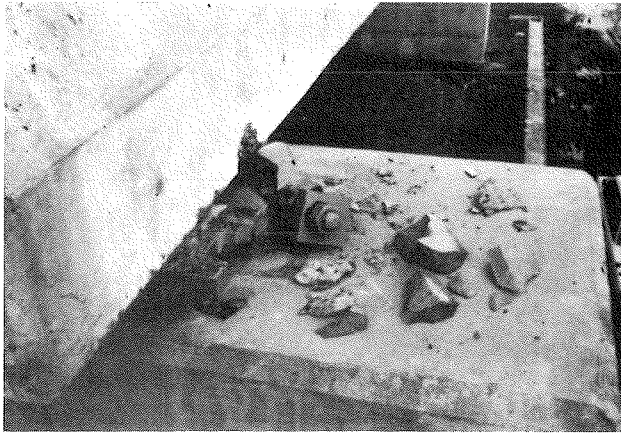
Fig. 2-6 Damaged Cast Iron Shoe

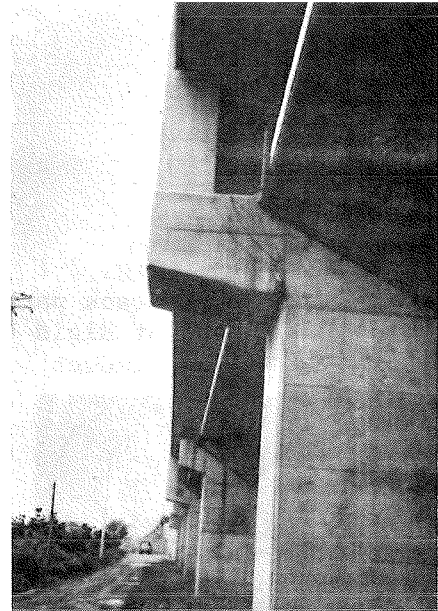
Fig. 2-7 Girder-Type Viaduct and Diagonal Cracks of Short Gasset

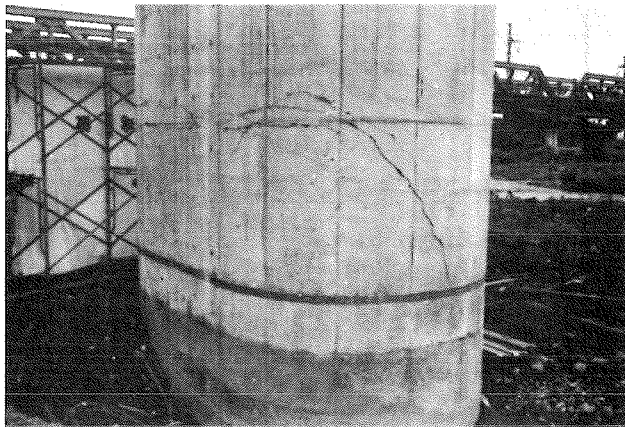
Fig. 2-8 Pier of 4-span Continuous Prestressed Concrete Bridge

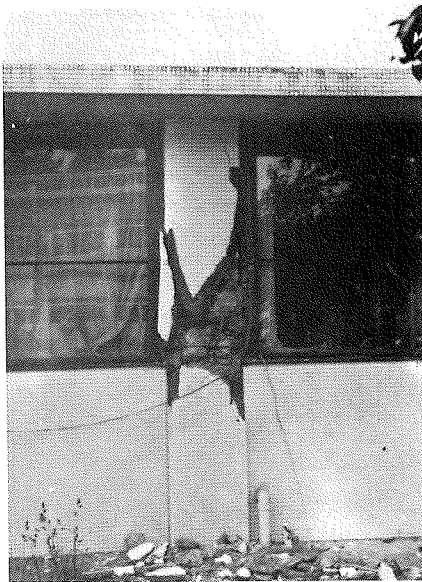
Fig. 3-3 Damaged Pillar (Designed by Old Regulations)

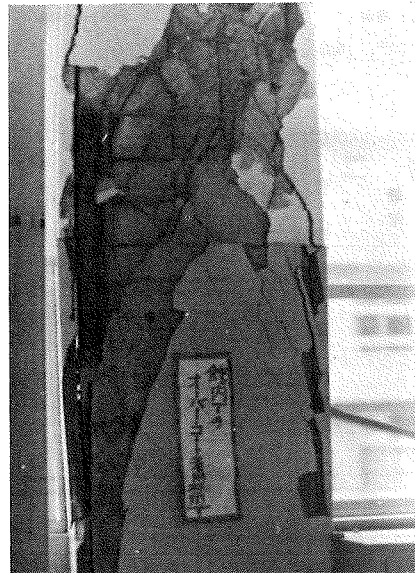
Fig. 3-4 Damaged Pillar (Designed by New Regulations)

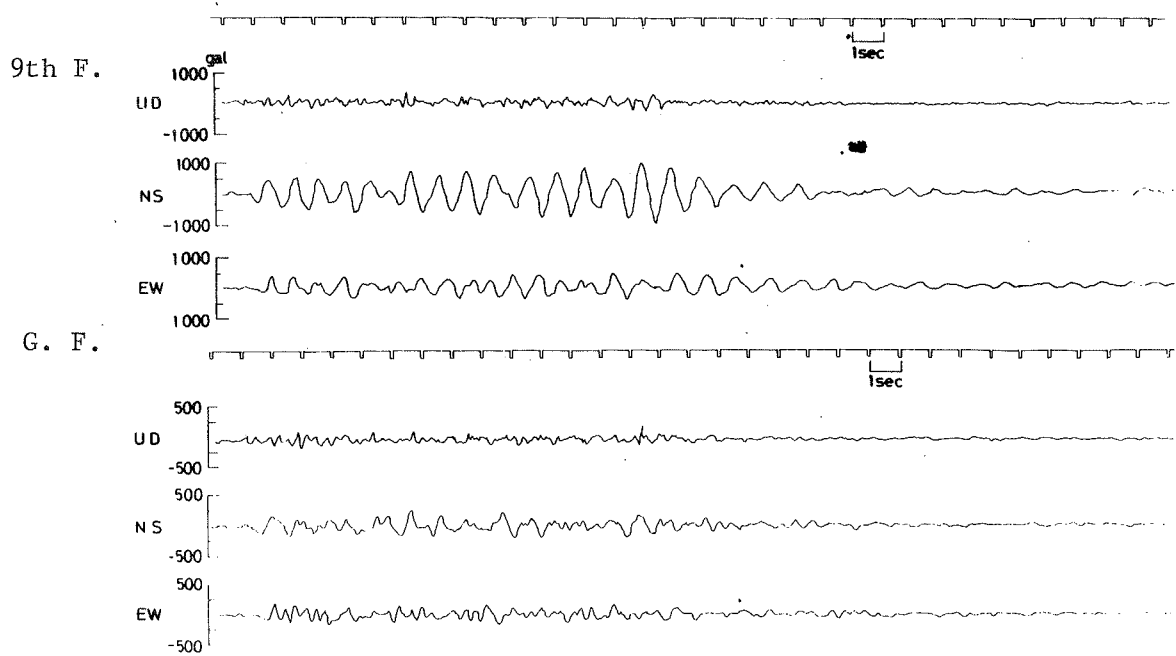
Fig. 3-5 SMAC Recorded obtained at an Univ. bldg.

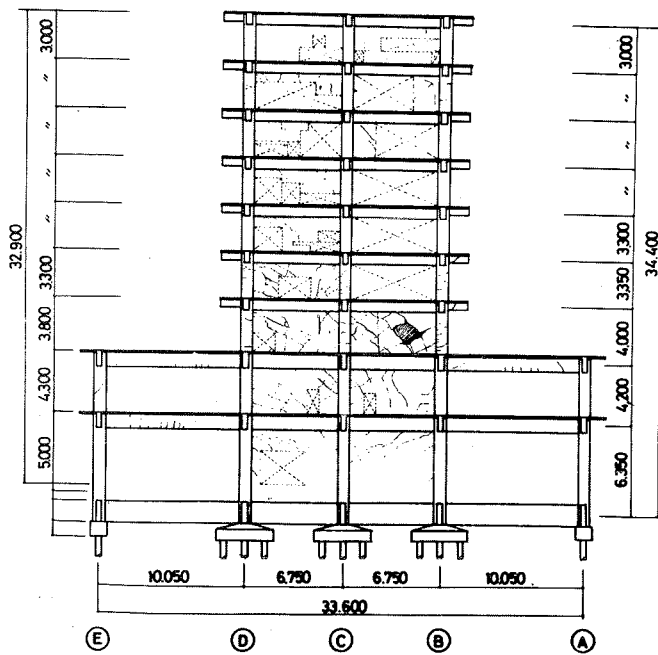
Fig. 3-6 Crack pattern of the Univ. bldg.

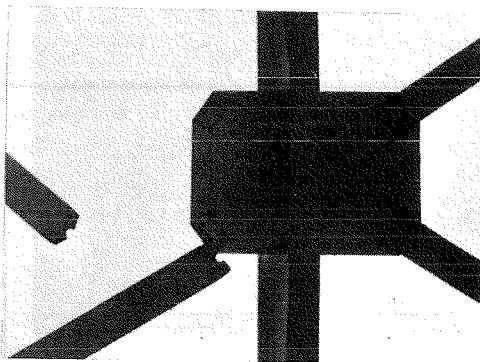
Fig. 3-9 Ruptured bracings

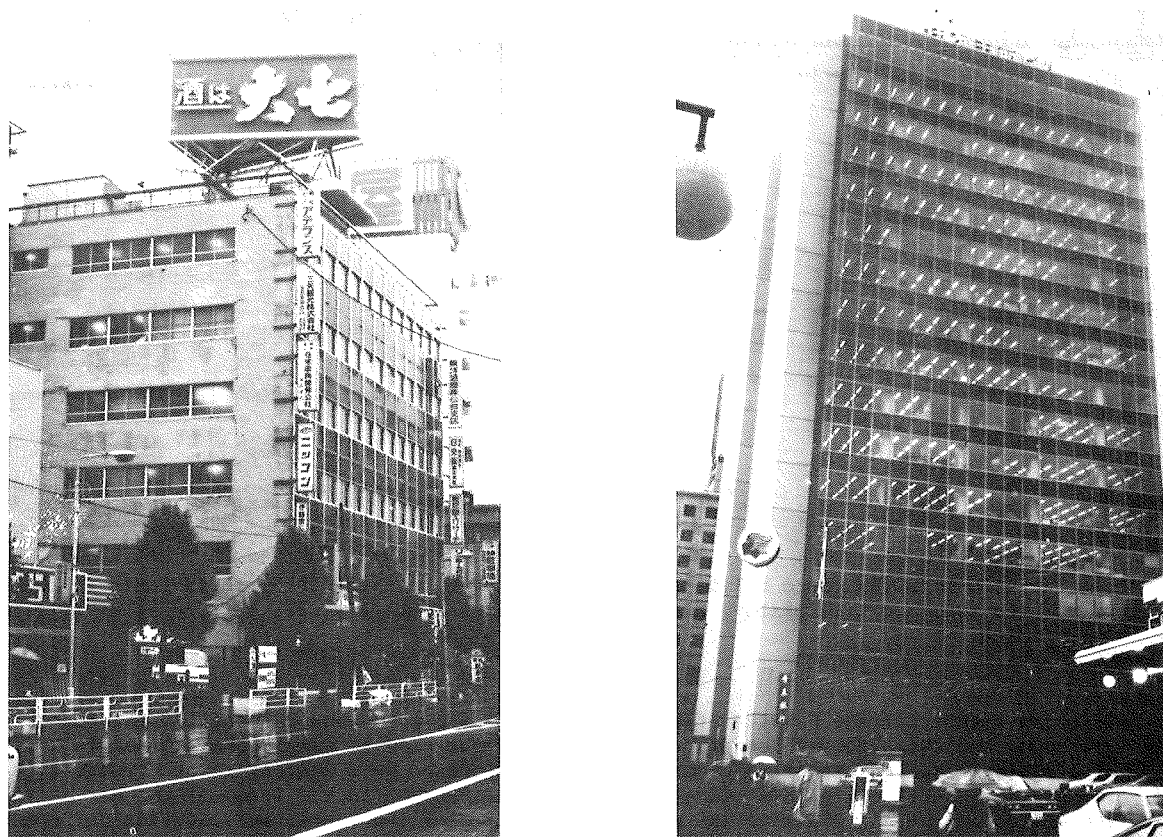
Figure 3 Two typical high-rise buildings in Sendai. The 6-story reinforced concrete Minami Machidori building, on the left, suffered extensive cracking to its brick veneer facing and shows signs of possible structural damage as well. The 18-story Sumitomo Life Insurance building, shown on the right, suffered cracking at the interior concrete shear walls of its upper stories.

forced concrete Minami Machidori building suffered significant damage; however, there were no collapses despite the high ground acceleration recorded and the long duration of strong motion. The 18-story Sumitomo Life Insurance building is one of the highest structures in Sendai. The structure was designed with the aid of dynamic analyses and was constructed in 1974. The three-floor underground portion of the building is of SRC construction. The 18-story superstructure (and 2-story penthouse) has a steel frame with continuous, full-height, symmetrical concrete shear walls on two sides of the exterior and around the interior elevator core. From in-situ low g-level testing, the natural frequencies of the building in the two horizontal directions are found to be approximately 1.19 and 1.25 Hz; the structure is relatively stiff for its height, probably because of the presence of shear walls.

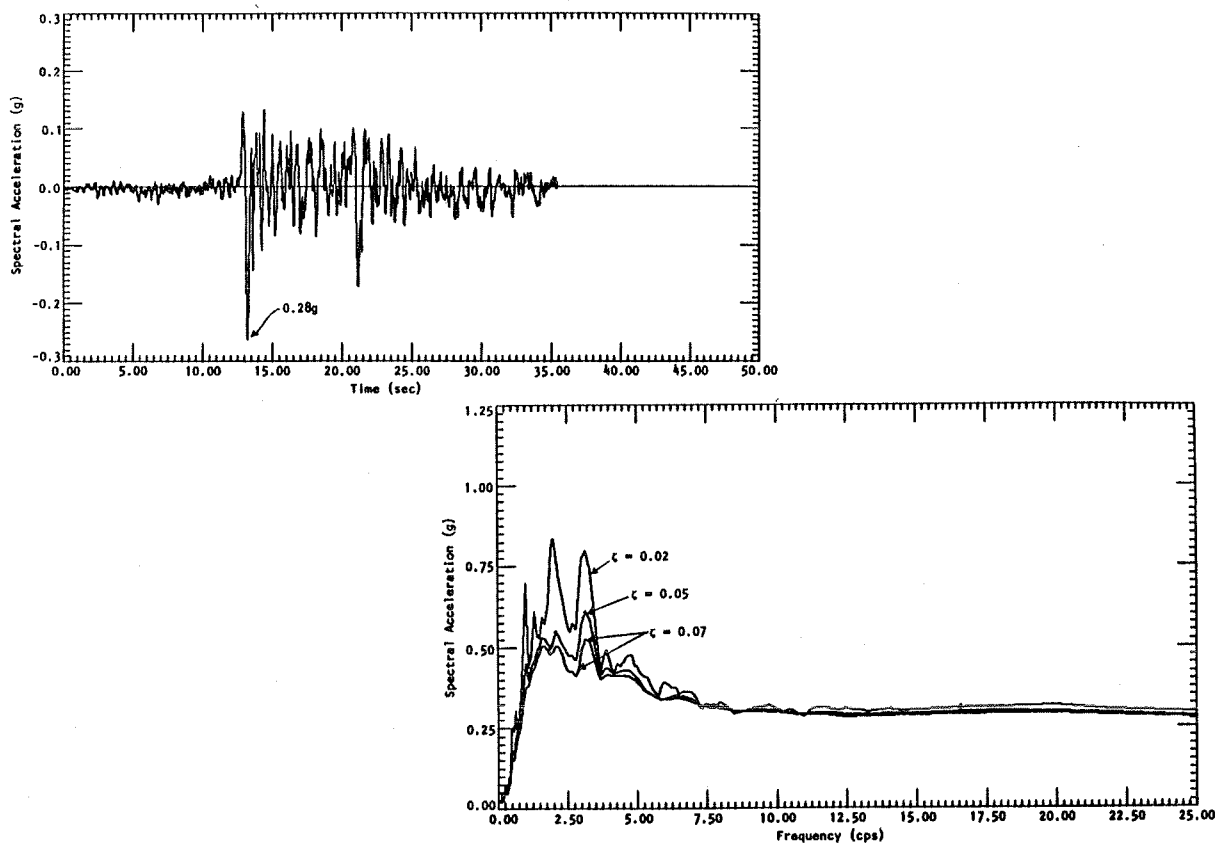
Figure 4 Sumitomo Life Insurance building. The uncorrected basement (B2F) north-south component of the recorded time history and its acceleration spectra at 2%, 5%, and 7% of critical damping.

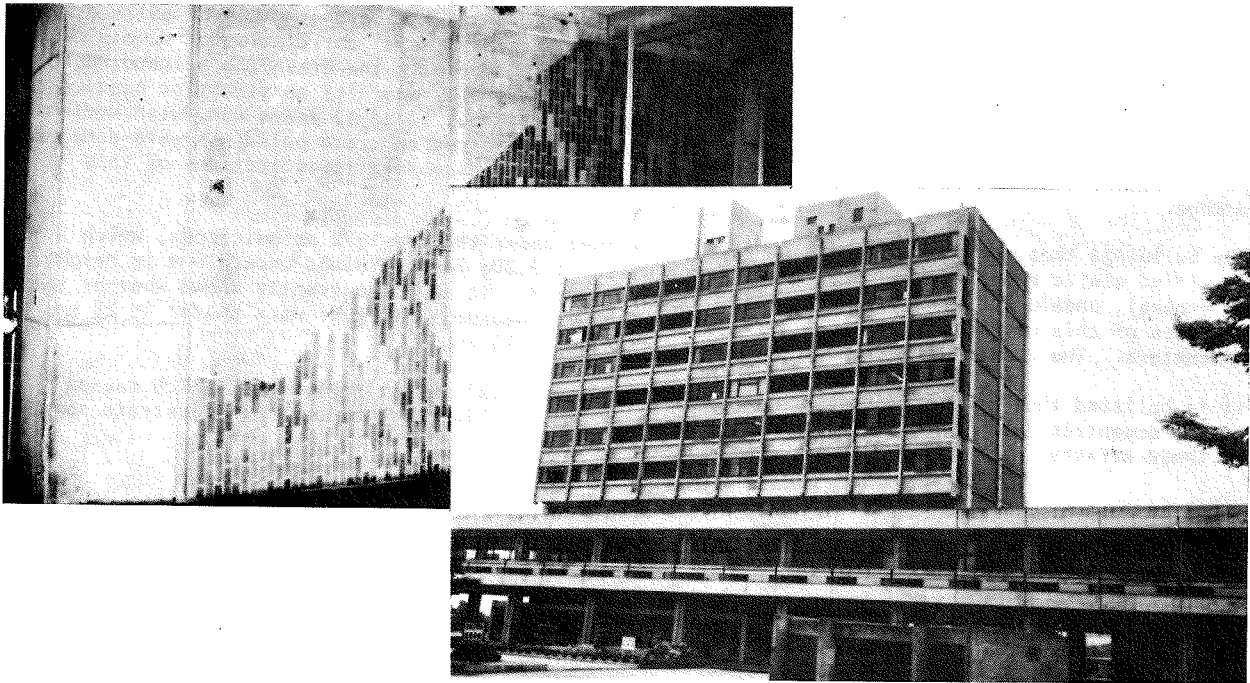
Figure 5 Faculty of Engineering building, Tohoku University: a general view (right) of the 9-story reinforced concrete frame building and a damaged transverse shear wall at the ground floor (left). Some of the glazed tile veneer has spalled along and above a diagonal crack.

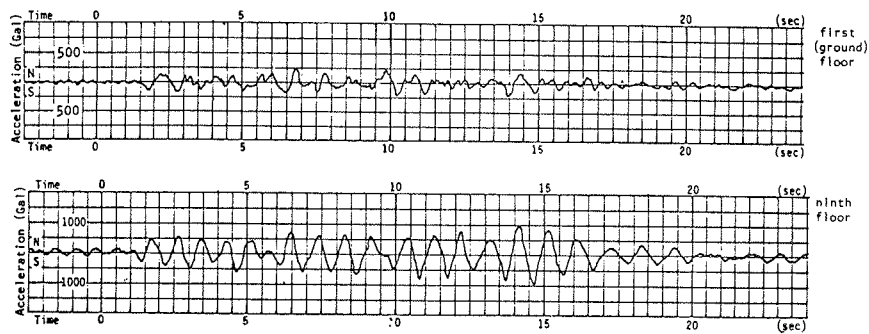
Figure 6 The ground-floor and ninth-floor acceleration time histories in the north-south direction; Faculty of Engineering building, Tohoku University (Courtesy Building Research Institute, Japan)

Figure 6 shows the north-south acceleration records from the ground and ninth floors. The east-west records are similar but have lower amplitudes. In the north-south direction, the building experienced about 15 sec of continuous motion at the ninth floor that was between 0.5g and 1.0g and about 20 sec of motion greater than 0.25g. A preliminary analysis (performed by BRI) of the high-amplitude (1.0g) oscillations in the north-south direction at the ninth floor indicates that the displacements involved are about ± 25 cm. Results of spectral analyses by BRI for the east-west component first at the floor are shown in Figure 7.

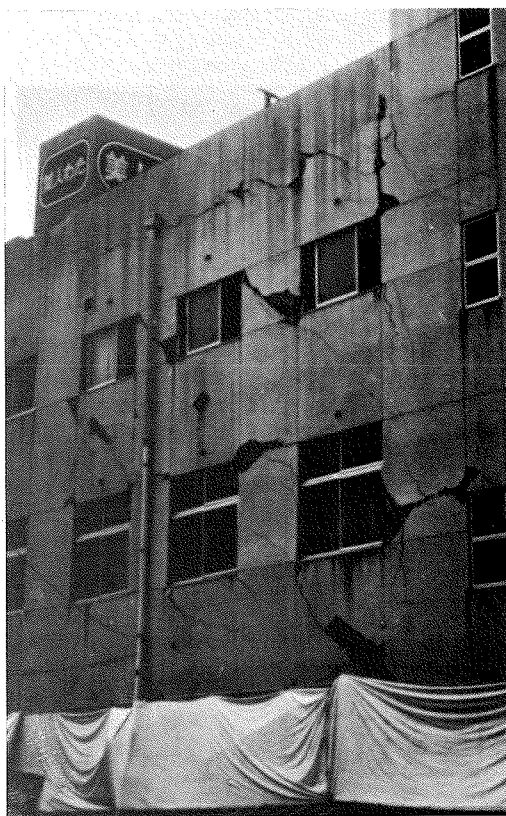
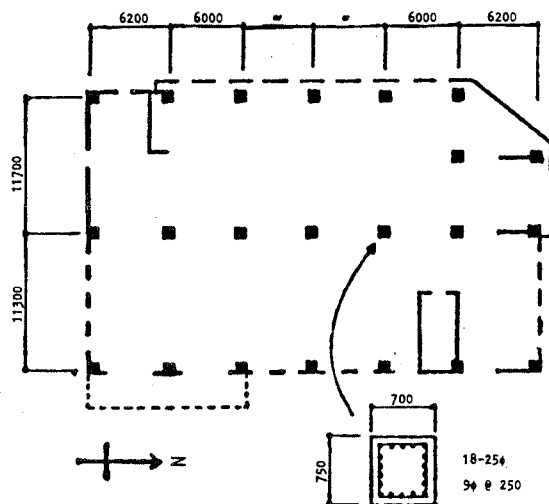
Figure 9 Kinoshita building, Oroshicho area, Sendai: view from the east (rear). This 3-story reinforced concrete building is two spans by six and was completed in 1969. The two spans in the east-west direction are long: approximately 11.5 m each. The structure is essentially a frame building. The first-floor columns along the centerline of the building in the north-south direction failed. In addition, the transverse foundation of the structure settled 10 to 15 cm along a middle column line, contributing to the extensive diagonal cracking. (Photograph courtesy J. D. Cooper)

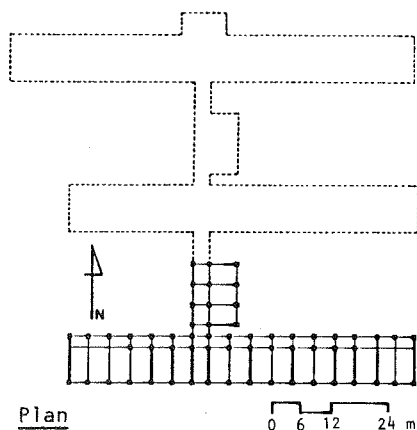
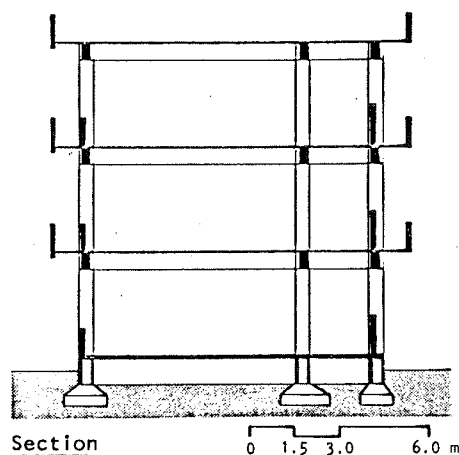
Figure 10 Plan and section of Izumi High School. The school's three adjacent reinforced concrete frame shear-wall structures, constructed after 1971, were damaged, but the school remained functional. Note in the plan the absence of shear walls in the east-west direction and the termination of the north-south shear walls at the corridor. Where shear failure in columns occurred, the architectural configuration had created short columns by the use of deep-poured concrete infill spandrels on one facade of the building but not on the other. The section shows how these spandrels, on the right, created short columns. (The opposite facade had longer, free-standing columns.) Furthermore, the use of shear walls in the north-south direction of these heavy, frame buildings was limited or omitted entirely because of the architectural need for full daylighting to classrooms. (Illustration courtesy C. Arnold)

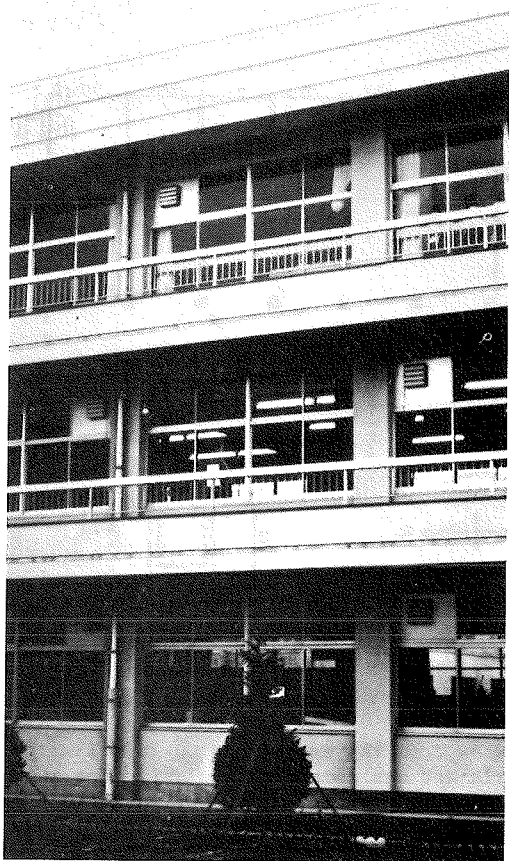
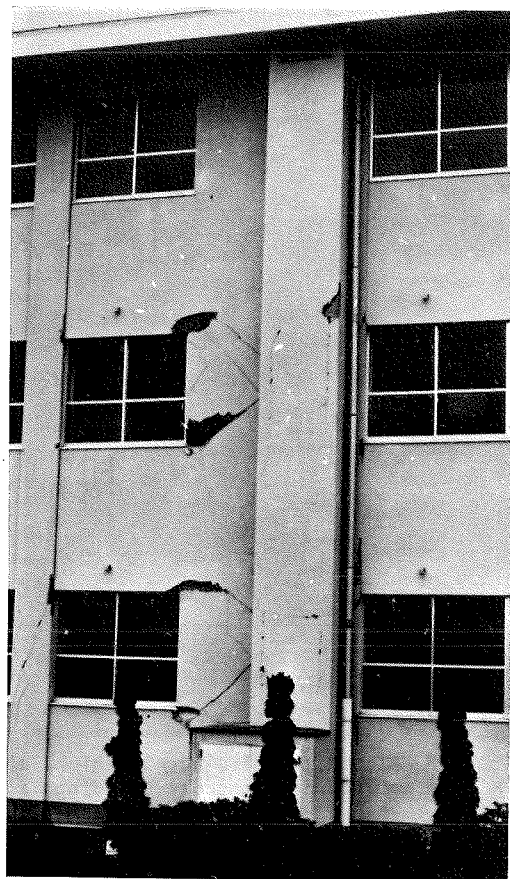
Figure 11 Izumi High School. The two illustrations show, respectively, two sides of a typical building. The rear of the building (left) is relatively open and suffered little apparent damage; damage was heavier on the side with partial-infill wall panels (right). The interior transverse shear walls frame into the columns on the rear but do not frame into the columns on the front because of a longitudinal corridor. All three buildings performed in the same manner.

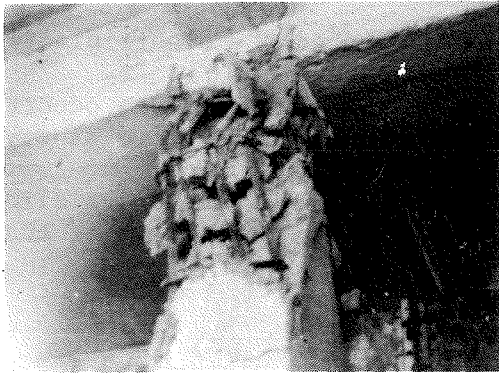
Photo 1 Damage at the top part of a column in the 2nd floor.

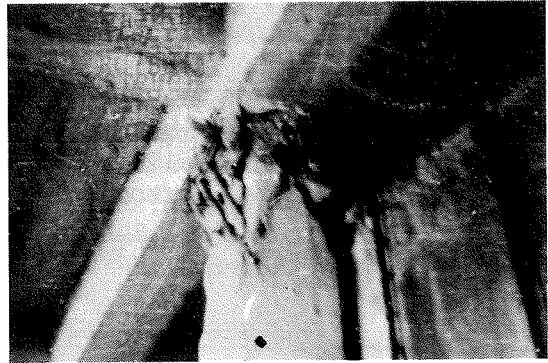
Photo 2 Damage at the top part of another column in the 2nd floor.

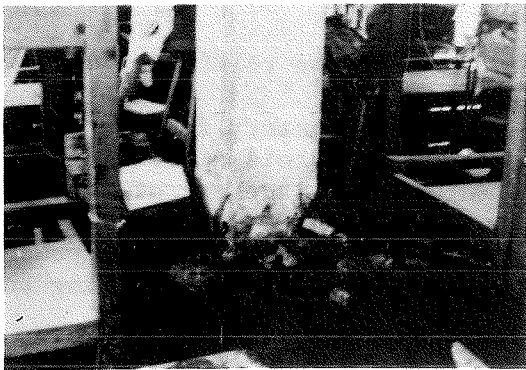
Photo 3 Damage at the bottom part of a column in the 2nd floor.

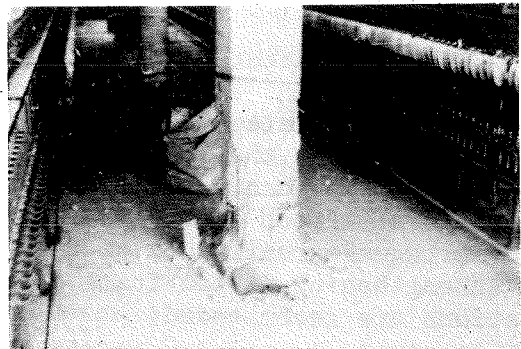
Photo 4 Damage at the bottom part of a column in the top floor.

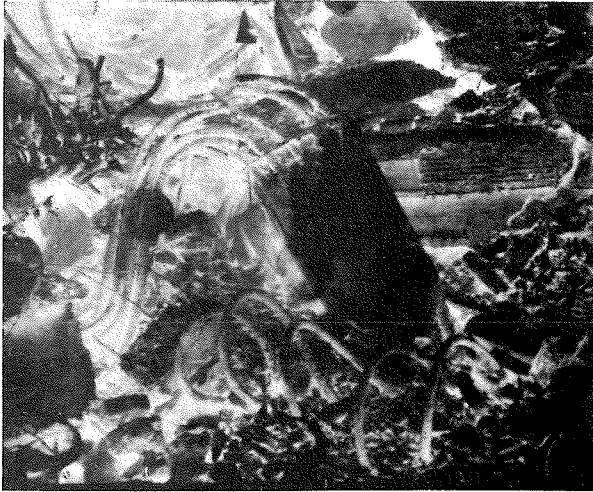
Photo 5 Collapse of the framed structure (view 1).

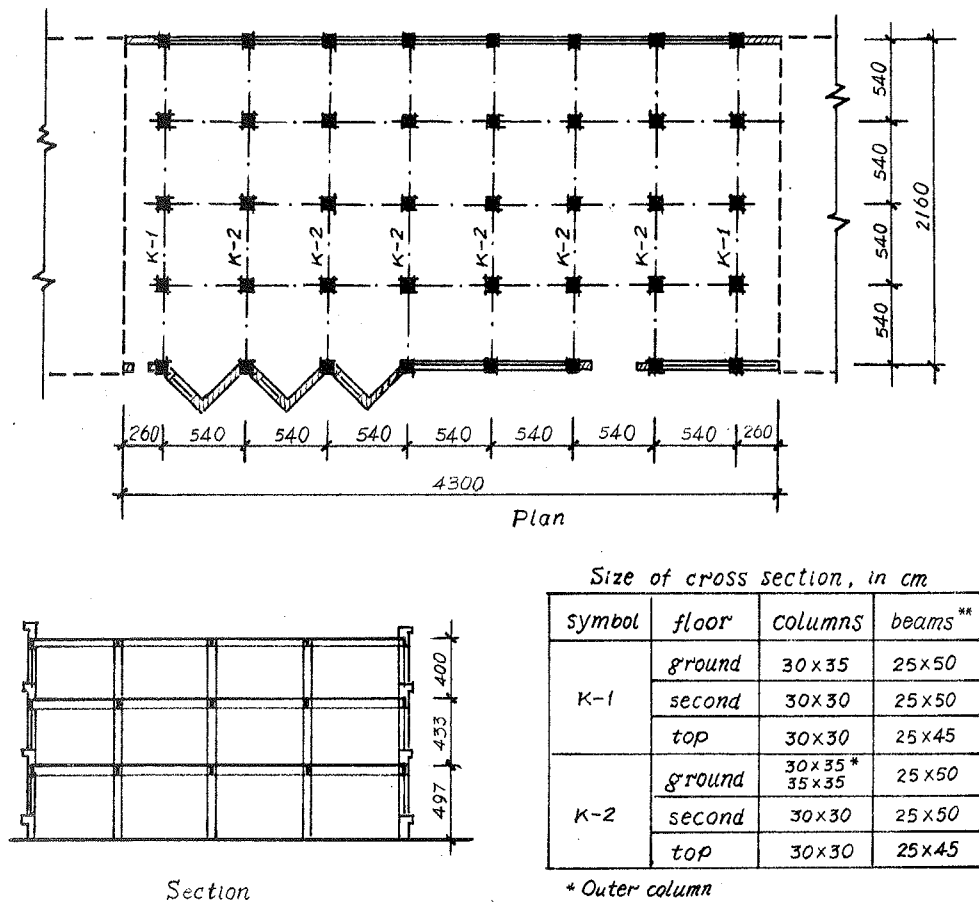
Fig.1 Plan and section of the factory structure.

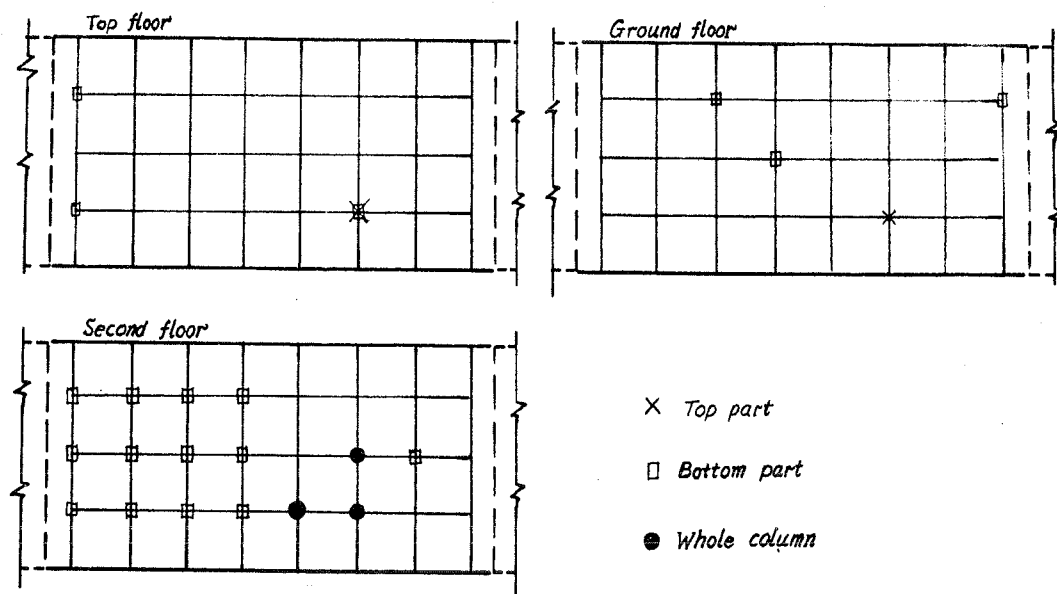
Fig.2 Strengthening of the damaged columns after the major shock.

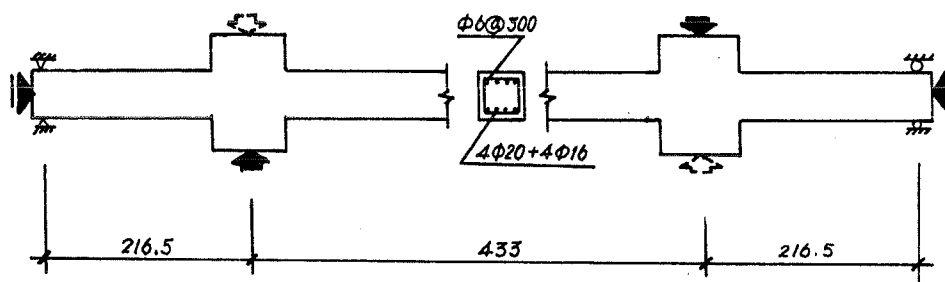
Fig.3 Arrangement of the full size model column.

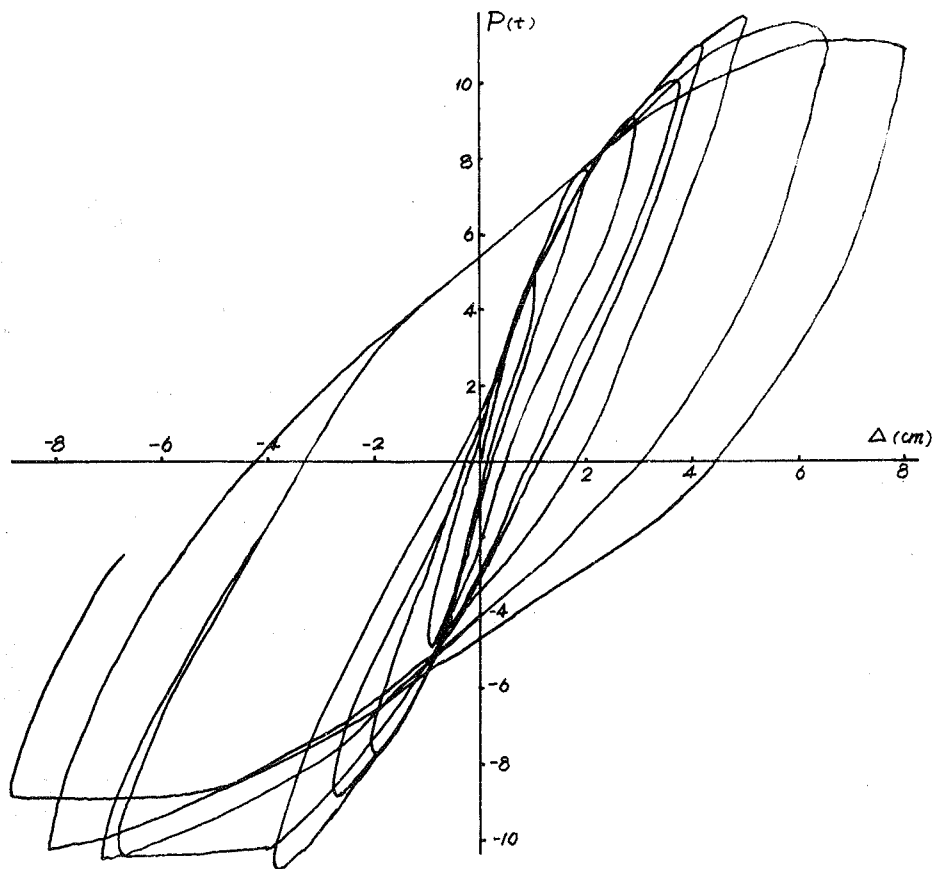
Fig.4 Load-deflection curve under cyclic loading.
