THEME III

SEISMIC BEHAVIOUR OF STRUCTURAL CONCRETE TWO-DIMENSIONAL
ELEMENTS (SHEAR WALLS AND OTHERS)

NON-LINEAR ANALYSIS OF REINFORCED CONCRETE SHEAR WALLS

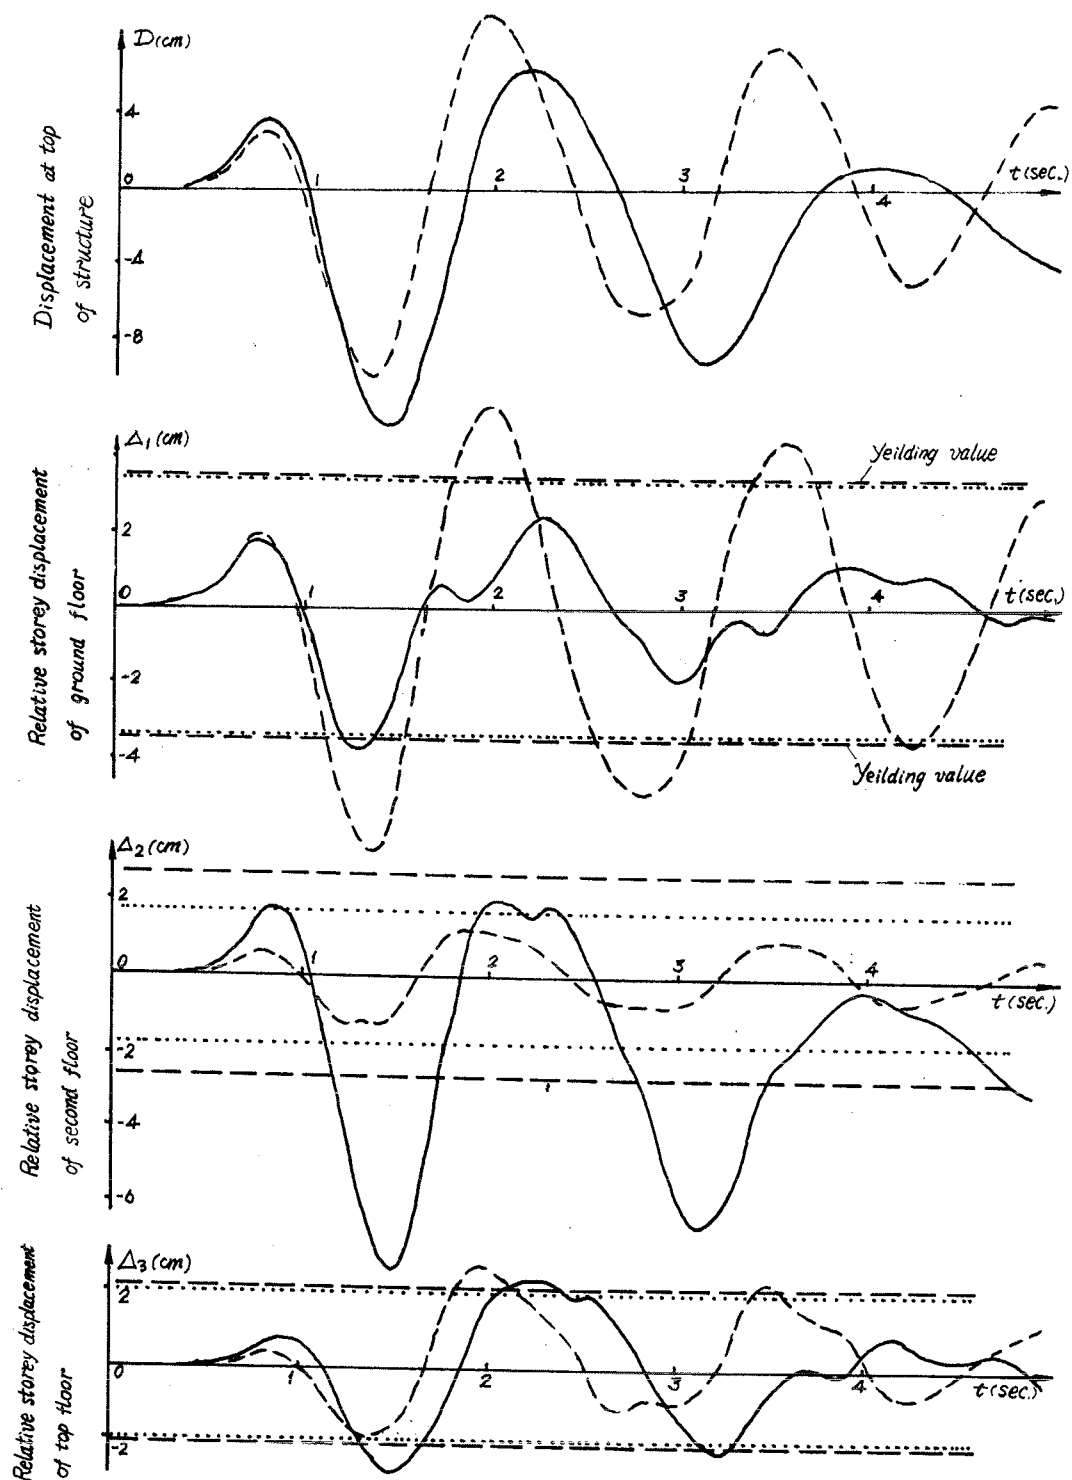
Fig.6 Comparison of the storey displacements response between the unstrengthened structure and the strengthened one (by storey shear model).

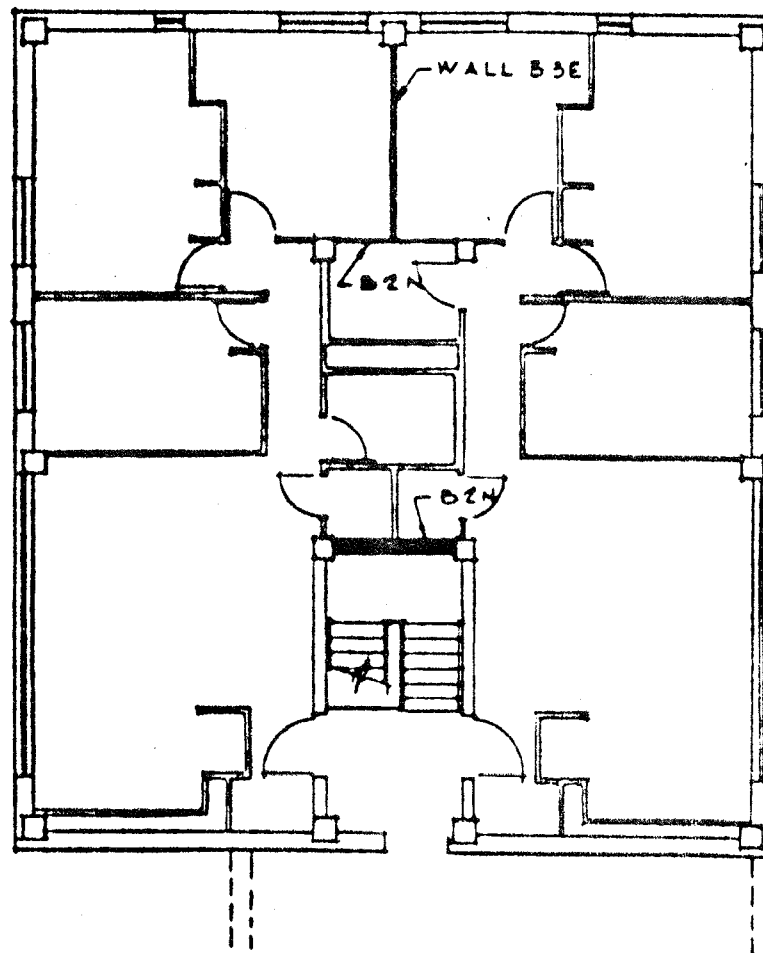
FIGURE 2
Shear Wall Plan
